Luxulyan Valley

Conservation Management Plan - Gazetteer

Cornwall Heritage
Trust

July 2011 - Rev.03

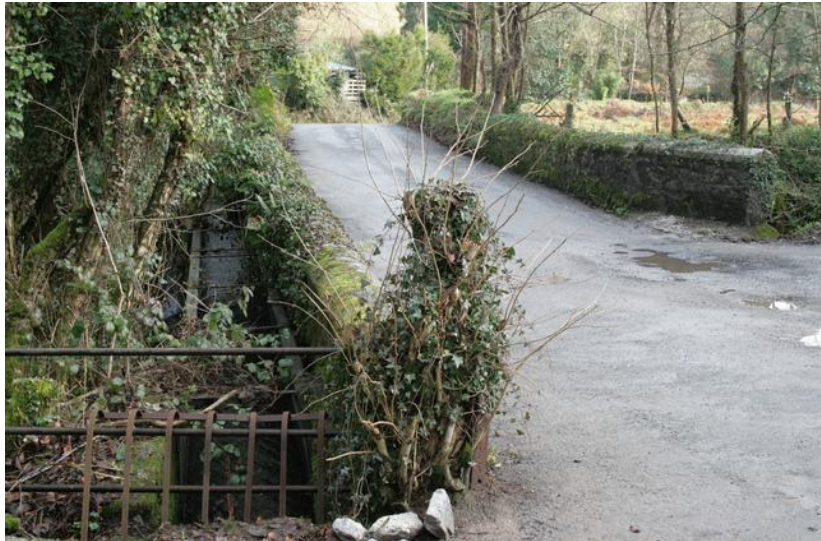
URS Ref: 1	Asset: Ponts Mill Bridge

CAU Ref: P1			
Description:		<p>Conservation Approach:</p> <p>Monitor the structure of the bridge and its load bearing capabilities.</p>	
Condition:	Significance: Moderate		
Good	Retains historical, evidential and aesthetic values. A good example of a local road bridge.

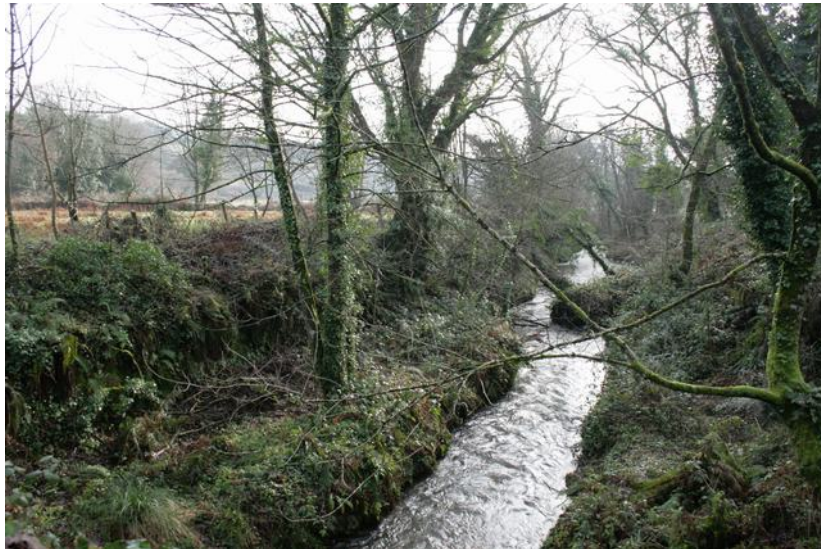
URS Ref: 2	Asset:

CAU Ref: P2 &P3	Par canal		
Description:			<p>Conservation Approach:</p> <p>Manage the vegetation growth to sustain both the alignment of the canal and a free flow of water. Trees to be managed in accordance with the principles of ecological management as set out in the CMP. Upper basin to be managed in accordance with any future opportunities in respect of the stone mills.</p>
<p>The canal was constructed c1835 from the port at Par and initially terminated at the foot of the Fowey Consols incline, it was extended to Pons Mill by 1840 but apparently disused by 1850.</p> <p>The lower sections of the canal on the south side of the road bridge, comprise a shallow broad cut now part silted and overgrown. The upper basin, north of the bridge is almost entirely silted over and discernable as a very broad wet depression. The upper basin has clearly been re-shaped by later working and dumping including more recent clearing.</p>

Condition:	Significance: High		
<p>The canal is now mostly silted up and part infilled with rubbles.</p>	<p>The canal evidences Treffry's engineering endeavours to link his industrial operations to the Port at Par. The excavation of the canal was instrumental to the exploitation of the resources within the valley. Its silting has affected its evidential and aesthetic values.</p>

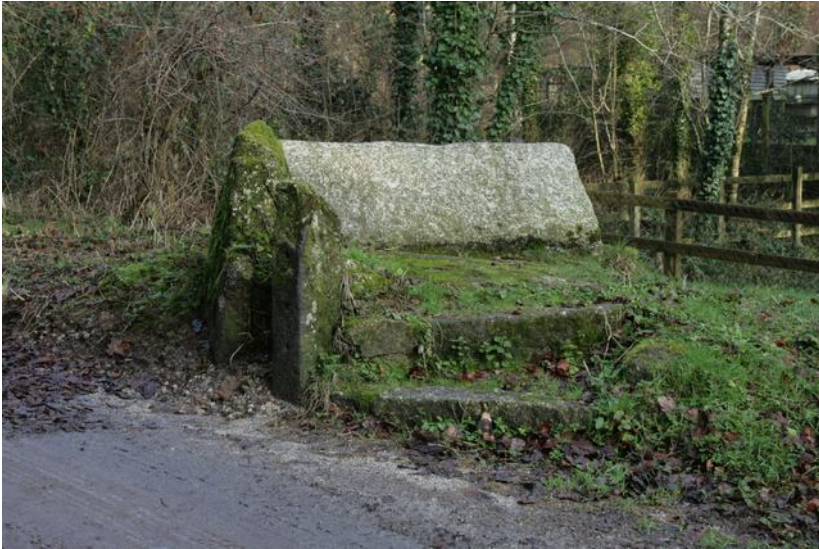
URS Ref: 3	Asset:

CAU Ref:	Base for information board.		
<p>Description:</p> <p>Granite stone stepped structure located on the east side of the tramway no w roadway alongside the former Par Canal. J Smith <i>pers comm</i>. States that this was an information panel erected in 1996. .</p>			<p>Conservation Approach:</p>
Condition:		Significance:

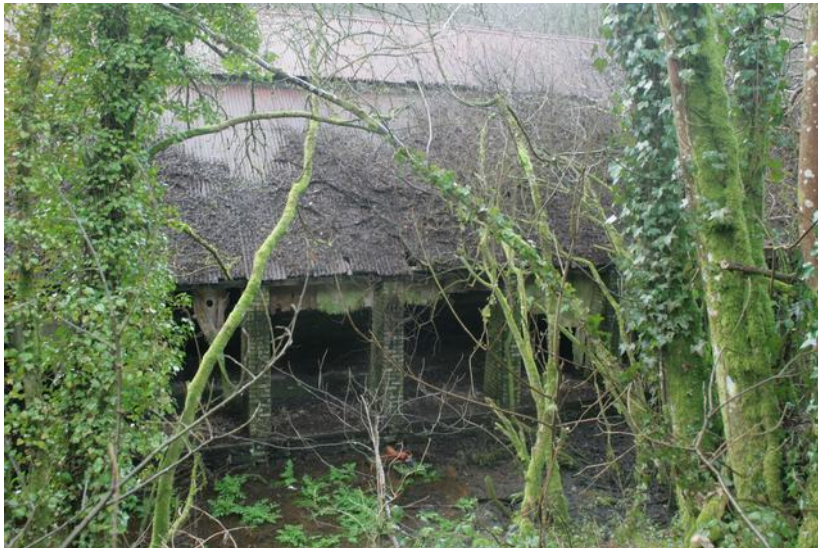
URS Ref: 4		Asset: Remains of pan kiln

CAU Ref: C4/2			
<p>Description:</p> <p>The pan kilns at Pons Mill are in a ruinous condition and not accessible. The structure appears to be of traditional form with the kilns arranged to the front and settling tanks to the rear. The structure has no doubt been extensively modified and the existing corrugated metal roof is carried on a timber superstructure supported on its eastern side by a series of brick piers.</p> <p>The settling tanks are lined in concrete and overgrown. There are a number of other various stone foundations in the vicinity that are likely associated including the remains of the rail head and associated structures.</p>			
<p>Condition:</p> <p>Poor</p>		<p>Significance :Low to Moderate</p> <p>These were amongst the first of the new china clay mills to be built within the valley and parts may date to the 1870s. It is currently difficult to determine plan form or chronology. The china clay works are of general significance to the heritage values of the valley.</p>	<p>Conservation Approach:</p> <p>A full building record and condition survey is recommended to determine significance and extent of decay. The results of the survey will determine an appropriate management strategy. The continued decline of the building threatens evidential value which may in any case have been reduced on account of later alterations and rebuilding.</p> <p>The site of the building is waterlogged and the ability or necessity to drain the site will affect future decisions concerning the use or future of the building.</p>

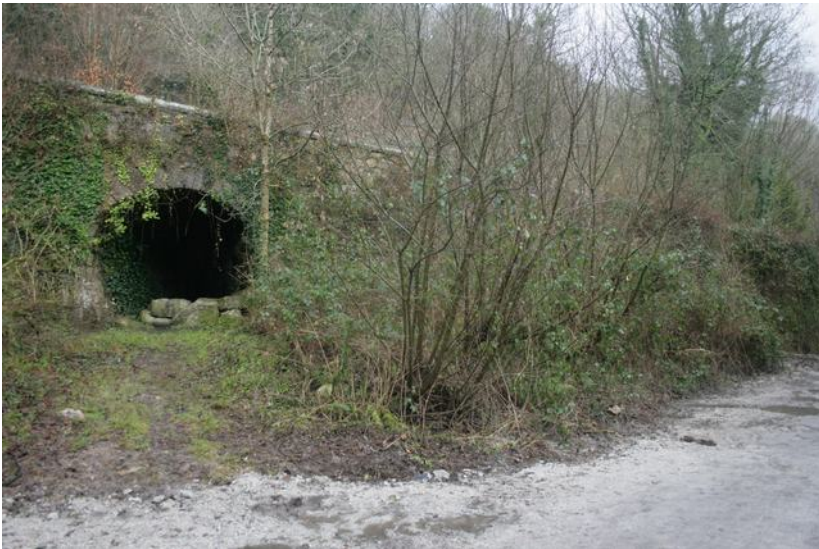
URS Ref: 5	Asset: Bridge and revetment wall at base of Carmears incline

CAU Ref: T4			
<p>Description:</p> <p>Stone single span bridge c1838 and revetment that carries the Carmears Incline from Pontois Mill up the east side of the valley. The revetment follows closely the angle of the incline and is provided with a parapet with rounded stone coping. The portal is faced in dressed voussoir stones.</p>			<p>Conservation Approach:</p> <p>Monitor structural condition and manage vegetative growth to reduce threat to structural integrity. Undertake structural survey and implement any recommended actions.</p> <p>As the tramway is very occasionally used as a means of access for maintenance vehicles, it is necessary to define its load bearing capacity and impose appropriate weight restriction on any vehicle.</p> <p>The surface of the tramway is showing signs of general erosion and potential dislodgement of granite setts.</p>

<p>Condition:</p> <p>The structure is particularly overgrown on its eastern elevation, with traces of water ingress in the arch and potential root penetration of the structure.</p>	<p>Significance: High</p> <p>The bridge and revetment wall is an integral part of the Carmears Incline and retains good historical, evidential and aesthetic values.</p>

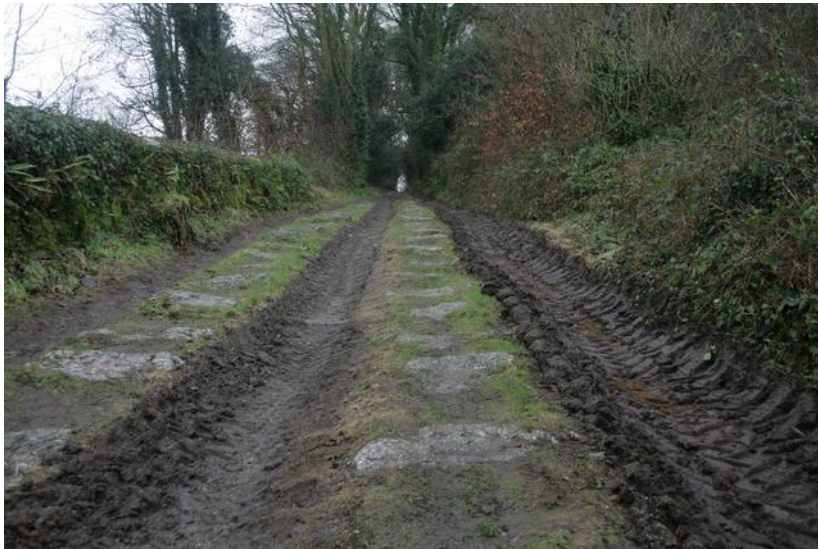
URS Ref: 6	Asset: Carmears Incline, Treffry's tramway

CAU Ref: T6			
<p>Description:</p> <p>Embanked and cut track way rising sharply from Pontois Mill up the eastern side of the valley. It crosses the Fowey Consols leat by means of a flat simple granite bridge.</p> <p>The track bed retains the granite setts that carried the rails with evidence of fixing of the chair plates. A series of pad stones runs along the centre of the tramway and carried the fixing for the wire guide rope.</p> <p>The incline was powered by the water wheel at the head of the incline which was itself powered by water from the Carmears Leat.</p>			
<p>Condition:</p> <p>The incline is in a poor condition and vulnerable. There is evidence for rutting and potential for displacement of the granite stones and general wear of the substructure. The revetment, embankments and parapets are generally in a good, though overgrown condition. Encroachment of vegetation on the edges is obscuring the alignment.</p>		<p>Significance: High</p> <p>The Carmears Incline was the method that Treffry adopted to run his tramway up the valley from its low point at Pontois Mill. It is a significant part of the heritage of the valley with a directly functional association with both the viaduct and wheel pit.</p>	<p>Conservation Approach:</p> <p>Restrict vehicular access.</p> <p>Reinforce substructure and consolidate the position of the granite setts. Undertake survey to ascertain potential damage from tree roots carry out any remedial action. Trim edges to reinstate the alignment where this has been encroached, particularly in those locations where the outer line of setts is now hidden.</p> <p>Recommend the tramway from Pontois Mill to the viaduct for designation as a Scheduled Ancient Monument.</p>

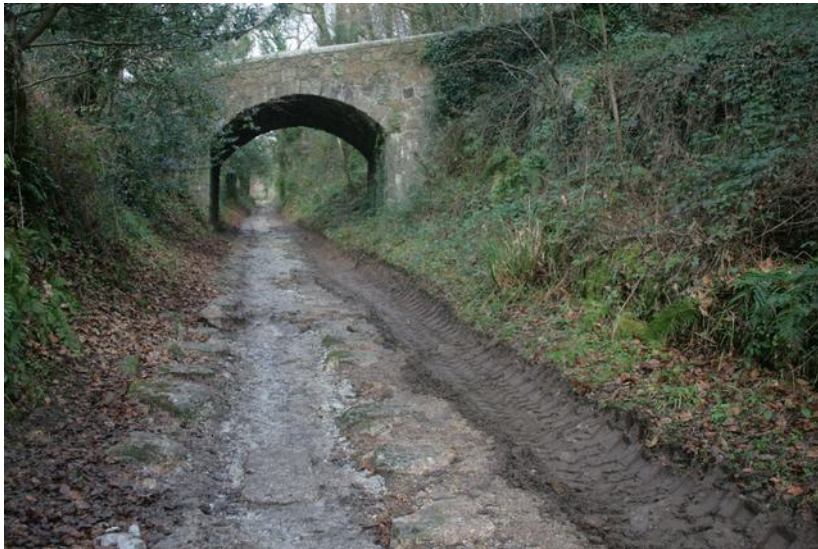
URS Ref: 7		Asset: Velvet Path over-bridge

CAU Ref: V10				
<p>Description:</p> <p>Single span arched bridge that carries the Velvet Path over the Carmarthen Incline. Probably built c1840 and part of Kendall's scenic drive. The arch is fashioned in dressed stone and is set slightly oblique to the line of the tramway. There is a low parapet with rounded coping.</p> <p>The abutments are obscured by vegetation on the edge of the cutting. The surface of the pathway is slightly metalled.</p>				
Condition:		Significance: High		
Good		The bridge is one of the few built structures associated with Kendall's picturesque path. It is a well proportioned and well built structure which provides a graceful crossing of the tramway. It has good aesthetic and historic values		
<p>Conservation Approach:</p> <p>Monitor structural condition and manage overgrowth.</p> <p>Works to better reveal the tramway alignment and granite stone setts along with edge clearance and control of vegetation on the sides of the cutting will all contribute to enhance the aesthetic significance of the composition.</p> <p>Recommend for designation as a Scheduled Ancient Monument as part of Treffry's tramway infrastructure and setting.</p>

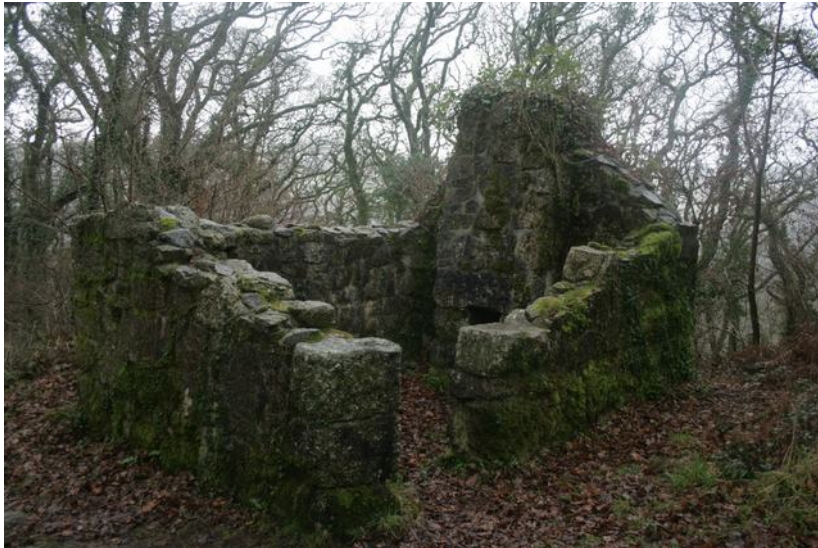
URS Ref: 8	Asset:

CAU Ref: T10	Incline head depot 'checkers cabin'		
<p>Description:</p> <p>Small single cell stone built building with chimney setting in gable wall. Evidence for a single doorway on the long side and a flat lintel window opening in the gable opposite the chimney.</p> <p>The building is located at the head of the incline on the west side of the tramway.</p>			
<p>Condition:</p> <p>The building is a roofless ruin with some vegetative overgrowth. The structure appears robust</p>		<p>Significance: Moderate</p> <p>Part of a collection of buildings at the head of the incline which evidences the transit between the incline and the regular horse drawn tram way that continues northwards towards the viaduct.</p>	<p>Conservation Approach:</p> <p>Monitor condition. Manage vegetation to maintain structural integrity.</p> <p>Recommend for designation as a Scheduled Ancient Monument as part of Treffry's tramway infrastructure.</p>

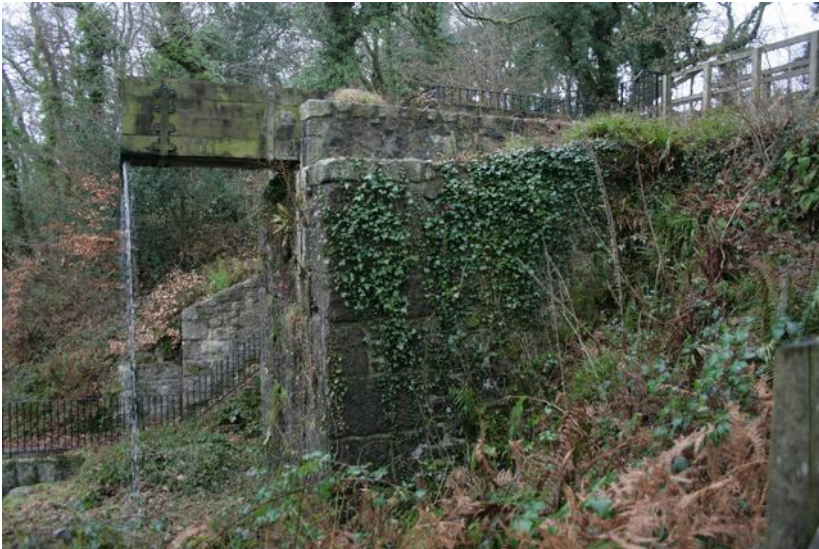
URS Ref: 9	Asset: Overshot wheel pit and timber launder.

CAU Ref: T12			
<p>Description:</p> <p>The Carmears Incline was powered by water driven overshot wheel. The wheel was set within a well constructed dressed stone wheel pit.</p> <p>Evidence for the form of the original setting has been obscured by later works when the site was used as a china stone mill.</p> <p>The existing timber launder is a more recent feature.</p>			<p>Conservation Approach:</p> <p>Monitor for structural integrity. Manage vegetation in accordance with principles of ecological management as set out in CMP.</p> <p>Recommend for designation as a Scheduled Ancient Monument as part of Treffry's tramway infrastructure</p>
<p>Condition:</p> <p>The wheel pit is in a good condition with some overgrowth.</p>	<p>Significance: High</p> <p>The remains of the various structures at the wheel pit including those that delivered the power to the Carmears Incline are significant industrial remains. The asset retains extensive historical and evidential values for most of the industrial periods.</p>

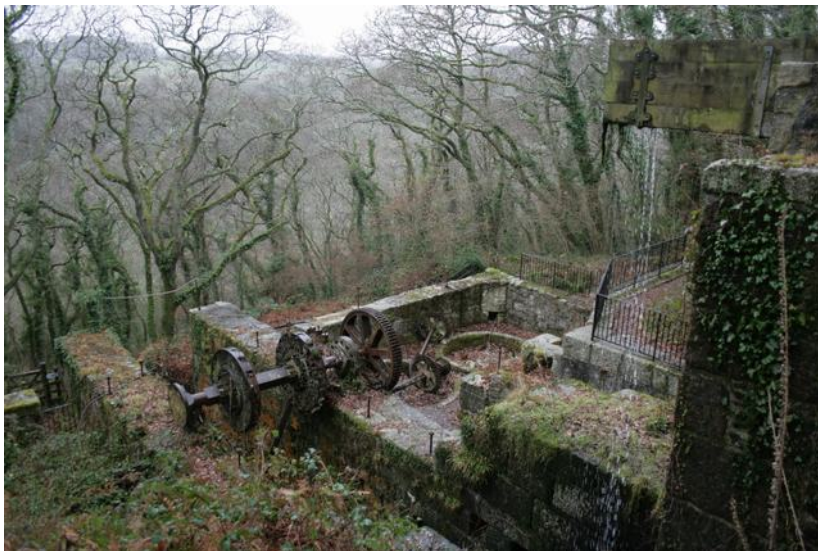
URS Ref: 10	Asset:

CAU Ref: C3	China Stone Mill		
Description:			
<p>Historic photographs document a rectangular building with a stone base and timber clad super structure. The wheel was set central to the structure with grinding pans to each side driven by horizontal shafting.</p> <p>The remains comprise the stone base within which are the pans and various artefacts including gears and drive shafts including elements of the water wheel.</p> <p>The mill was powered by water from the Carmears Incline. The china stone was transported along the tramway from Luxulyan and the crushed stone was carried in a pipeline alongside the Carmears Incline to the works at Pontois Mill.</p> <p>The remains of the mill are displayed in a ruinous condition there are safety rails around the site and access to the pans and between the upper and lower levels is controlled.</p>			
Condition:	Significance: High	Conservation Approach:

Only the masonry base is preserved along with some internal fittings and drive machinery. These are generally in a reasonable condition though becoming overgrown. The structure is mostly inaccessible though a viewing platform has been created alongside the launder.	<p>The china stone mills evidence the continued industrial use of the valley into the 20th century and the reuse of earlier structures. The mill retains much potential to reveal more evidence of form and process flow.</p> <p>There is potential for evidence of earlier remains to be present.</p>	<p>The railings around the site are a necessary safety feature though they detract slightly from the monument and its setting.</p> <p>If unchecked vegetative growth within and around the structure could affect evidential values. A survey and full assessment should be undertaken to inform any management decisions in respect of this significant site.</p> <p>Much of the character of the site is dependent upon impression given by the apparent abandonment of the machinery. Intrusive archaeological investigations are likely to disturb this aesthetic and any intrusive works should be carefully targeted to consider this aspect of the site's value.</p>

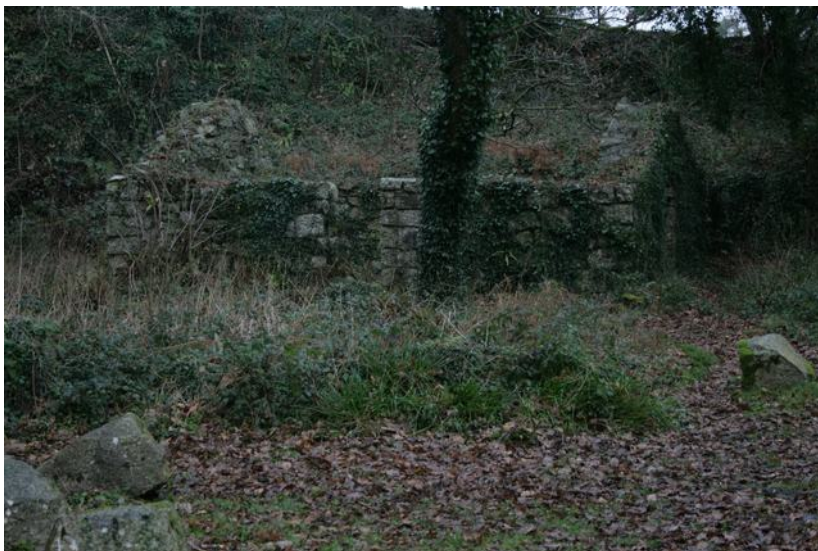
URS Ref: 11	Asset:

CAU Ref: T11	Building at Incline head depot		
Description:			
<p>Single storey single celled building of rubble stone with partly dressed quoins. Extant gable ends with chimney setting and window. Single doorway on the long side.</p> <p>The building is located on the east side of a level open clearing at the head of the incline.</p>			
Condition:	Significance: Moderate		Conservation Approach:
<p>The building is roofless and is overgrown and is being encroached on its rear by slippage of the earth bank.</p>	<p>Part of a group of buildings located at the head of the incline. Contributes to the group value of the assets each with historical and evidential values associated with the interface between the incline and the track way that extends towards the viaduct</p>		<p>Monitor condition and manage the vegetation to ensure structural integrity is retained. Investigate the earthen bank to the rear and undertake any necessary actions to stabilise so to remove threat to the structure.</p> <p>Recommend for designation as a Scheduled Ancient Monument as part of Treffry's tramway infrastructure.</p>

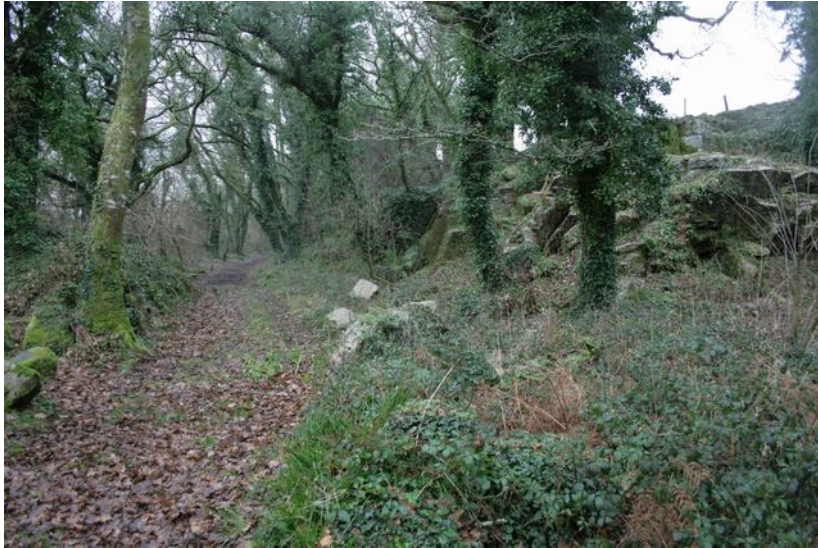
URS Ref: 12		Asset: Plinth for Incline drive shaft

CAU Ref: T14				
<p>Description:</p> <p>Large granite built raised plinth structure at north east extent of cleared area on the incline head.</p> <p>The structure has an irregular plan form and comprises rough coursed stone in an apparent stepped profile.</p> <p>The structure is in line with the Carmears Incline and may have supported a gantry head to support the wire drive wheel.</p>				
Condition:		Significance: Moderate to High		
Poor and partly overgrown and ruinous.		The structure retains a potential for historical and evidential values.		<p>Detailed survey and study is required to ascertain significance and purpose. This should be undertaken prior to any works of vegetation clearance or repair so to safeguard any heritage values.</p> <p>Recommend for designation as a Scheduled Ancient Monument as part of Treffry's tramway infrastructure</p>

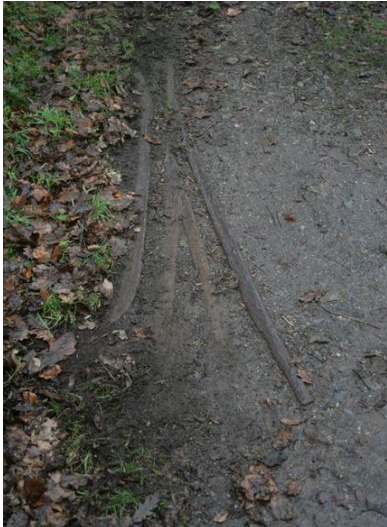
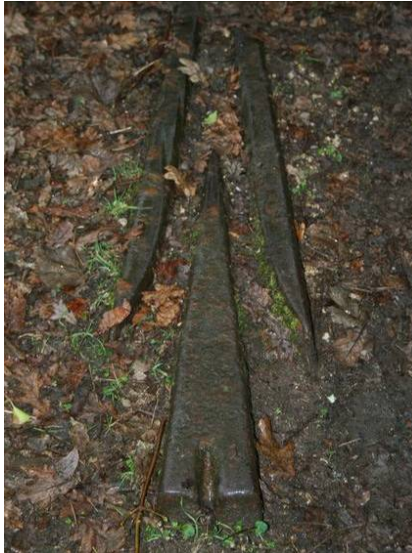
URS Ref: 13	Asset:	
CAU Ref:	Rails and turn out north of incline head	
<p>Description:</p> <p>Small length of tramway showing a turn out. There is no evidence for other remains of the tramway.</p> <p>From the incline head the tramway continued north on a near level plane through the middle valley. The length of curved track and turn out shows that the cleared area at the head of the incline was used for marshalling of the wagons.</p>		
<p>Condition:</p> <p>The structure of the tramway is mostly obscured and the location of granite setts can not be determined due to build up of earth</p>		<p>Significance: Moderate</p> <p>The rail provides evidential value in respect of the operation of the works at the incline head.</p>

<p>Conservation Approach:</p> <p>Monitor to ensure that the assets are not obscured or dislodged.</p> <p>Recommend for designation as a Scheduled Ancient Monument as part of Treffry's tramway infrastructure</p>
--

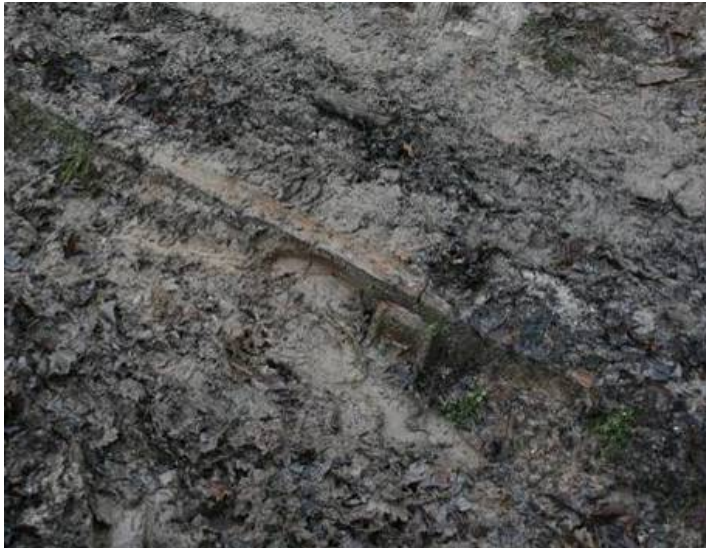
URS Ref: 14	Asset:

CAU Ref:	Tramway rail and chair		
Description:			<p>Conservation Approach:</p> <p>The extent of survival is unknown. Survey including some excavation would be necessary to determine extent of survival. There is risk of damage arising from the overburden and wear and the condition of the underlying tramway and its substructure needs to be determined prior to any recommendation for conservation which may comprise further revealing of rail and the laying of new substrate and drainage channels.</p> <p>Recommend for designation as a Scheduled Ancient Monument as part of Treffry's tramway infrastructure.</p>
<p>Condition:</p> <p>Much of the tramway as it passes through the middle valley is obscured by build up of earth and dumping and this has obscured its alignment and masked its character.</p>		<p>Significance: Moderate to High</p> <p>The tram rail and chair suggests a potential for in-situ evidence of the tramway and rails. The tramway is an important asset within the Luxulyan Valley. If more of it has been retained in situ then its significance increases on account of its regional rarity value.</p>

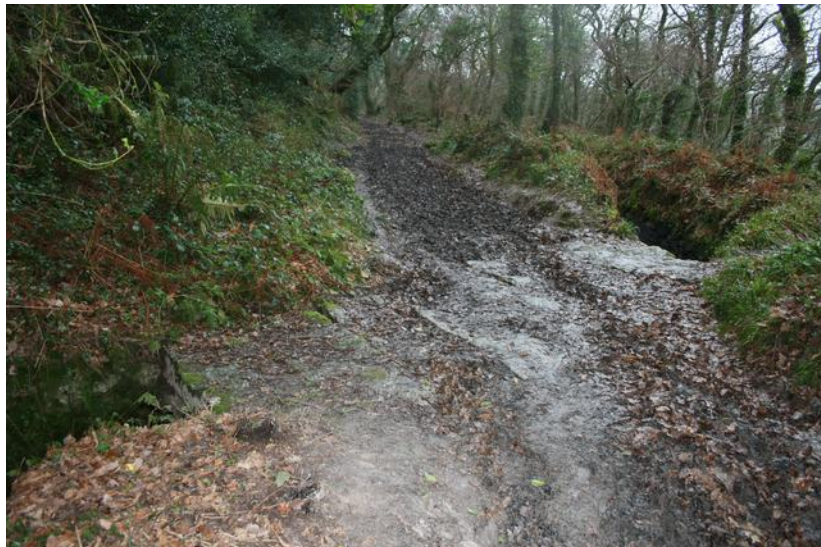
URS Ref: 15	Asset:

CAU Ref:	Bridges over Carmears Leat		
<p>Description:</p> <p>The tramway runs alongside the Carmears Leat for much of its length through the middle valley. The Carmears Leat follows a more sinuous route than that of the tram line and necessitates bridging of the leat in several locations. The bridges that carry the tramway over the leat are built of large granite sleepers set side by side across the leat.</p>			<p>Conservation Approach:</p> <p>Monitor condition and ensure structural integrity.</p> <p>Recommend for designation as a Scheduled Ancient Monument as part of Treffry's tramway infrastructure.</p>
<p>Condition:</p> <p>The bridges are all in a good condition and appear well bedded.</p>		<p>Significance: Moderate to Low</p> <p>The bridges are integral to the tram way which is of significance to the valley; Though the bridges themselves have little intrinsic merit their significance derives from group value.</p>

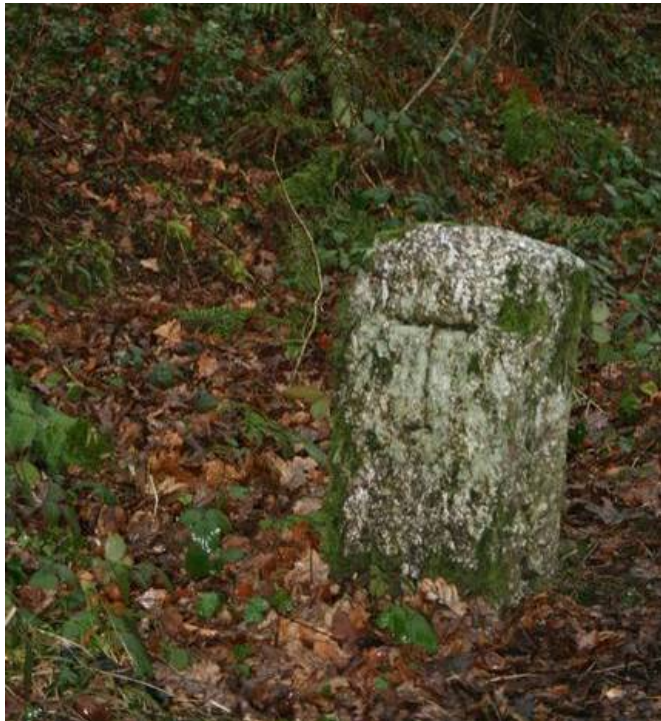
URS Ref: 16	Asset: Boundary stone

CAU Ref:		
<p>Description:</p> <p>Single granite stone set along side the tramway on the approach to the viaduct.</p> <p>The stone is inscribed on one face with a T for Treffry and on the other a K for Kendall.</p>		
<p>Condition:</p> <p>Good, the carvings are becoming obscured</p>	<p>Significance: Moderate to high</p> <p>The marker stone denotes the collaboration between Kendall, the landowner and Treffry the industrialist. The stone is of high significance and has high historical value in respect of the engineering of the valley by Treffry and its picturesque display by Kendall.</p>	<p>Conservation Approach:</p> <p>Monitor condition and ensure visibility.</p> <p>Recommend for designation as a Scheduled Ancient Monument as part of Treffry's tramway infrastructure.</p>

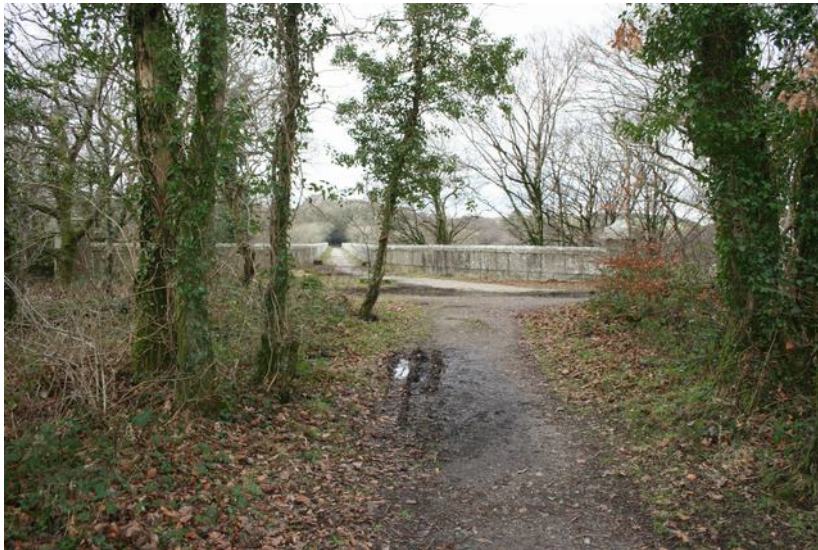
URS Ref: 17	Asset:

CAU Ref: T17	Marshalling yard on approach to Treffry Viaduct		
Description:			
On the approach to the viaduct the tramway enters a marshalling area at the junction with the Colcerrow branch. At the north end of the yard is a short length of rail with a turn out.			
Condition:		Significance: Moderate	Conservation Approach: Monitor condition and ensure that the turn out remains visible. Manage and check the encroachment of vegetation. Recommend for designation as a Scheduled Ancient Monument as part of Treffry's tramway infrastructure
The previous extent of the marshalling yard has been encroached upon by trees and vegetation. The tramway is obscured and buried by earth. The true alignment is not discernable.		The approach to the viaduct and junction with the Colcerrow Branch are key features of the valley and this location has good aesthetic values that contribute to the group value of the viaduct and other assets.

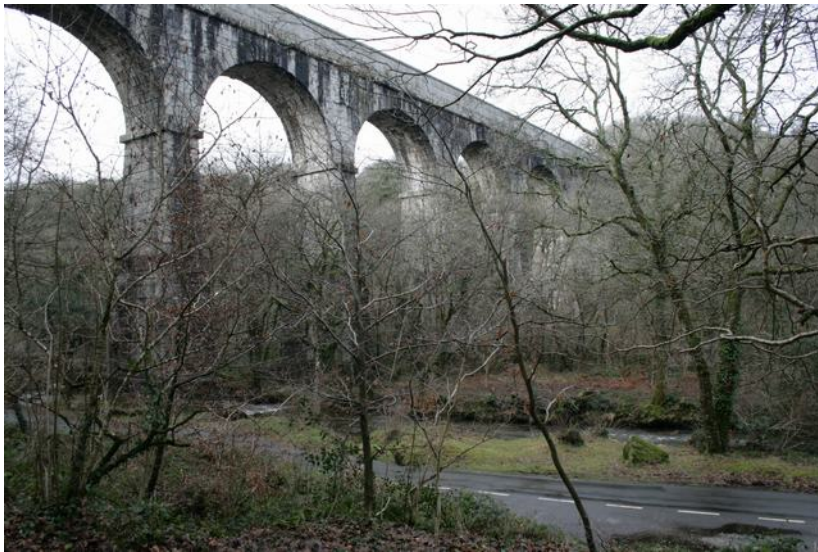
URS Ref: 18	Asset: Treffry Viaduct

CAU Ref: T19			
<p>Description:</p> <p>The viaduct is a Scheduled Ancient Monument.</p> <p>Ten arch granite viaduct that carries both the tram way across the River Par and in aqueduct the Carmears Leat. The arches are carried on slender piers with a cordon below the parapet. The Treffry coat of arms is displayed over the central span on the north face.</p> <p>The rail is carried on granite cross-sleepers the Carmears Leat is carried in a trough beneath the track bed. The sleepers retain evidence of their fixings.</p> <p>The viaduct is 200m long and 27m above the River Par. The viaduct bridges the River Par, the public highway and the CMR.</p>			<p>Conservation Approach:</p> <p>An approach to the conservation of the viaduct and repair to the Carmears Leat in aqueduct is contained within the separate condition report.</p>
<p>Condition:</p> <p>A full account of the condition is contained within the separate condition survey report.</p>		<p>Significance: Very High</p> <p>The viaduct is one of the more significant structures in the valley and a significant engineering structure within the region. It has significant historical, evidential and aesthetic values.</p>	<p>Recommend further survey and archaeological monitoring to determine condition of aqueduct along the entire length and modify repair approach as appropriate. There is a preference for a PP liner.</p>

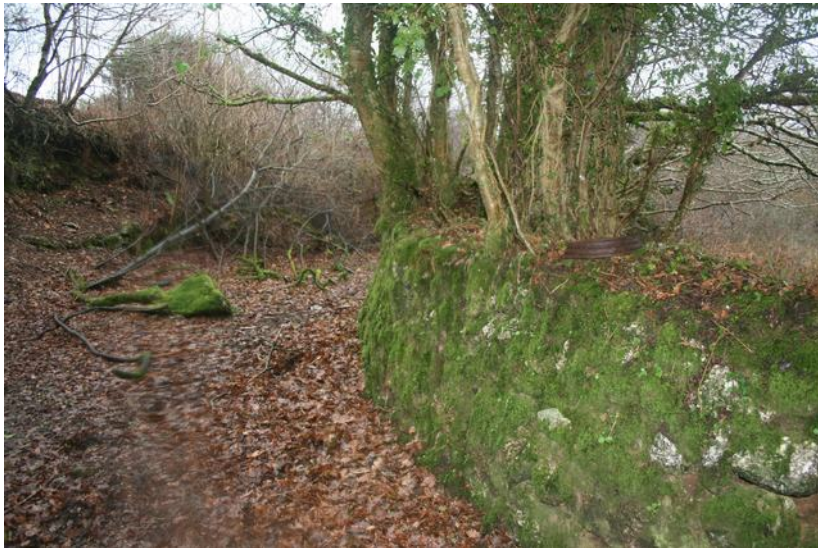
URS Ref: 19	Asset:

CAU Ref: T30	Tramway with stone hedges towards Cam Bridges to Luxulyan.		
<p>Description:</p> <p>On the west side of the viaduct the tramway enters a shallow broad cutting. This part of the tramway is difficult of access and waterlogged. As the tramway approaches Cam Bridges it is raised on a slight embankment as it leaves the Cam Bridges area the tramway is defined between stone built hedges. There is occasional evidence for stone sleeper pads but the tramway is mostly buried beneath soil build up.</p> <p>Close to the viaduct the build up of soils has totally buried any structural remains and its preservation is not known.</p>			
<p>Condition:</p> <p>The tramway is not easily accessible adjacent to the viaduct and is both buried and waterlogged. Later sections are more dry but overgrown. Alignment is however discernable and in general the condition when contained by stone hedges is good.</p>		<p>Significance: Moderate</p> <p>This part of the tramway has low evidential value and its condition ensures a low aesthetic. It is however of significance to the heritage of the valley and derives group value by association.</p>	<p>Conservation Approach:</p> <p>The tramway beyond the viaduct is in general in a poor condition and not as well used as other sections. The tramway should be managed in a way that sustains its heritage values and recognises the potential for sub-surface structures to remain.</p> <p>The recommendation of the survey report is that drainage of the tramway be improved. Archaeological investigation to determine preservation is required prior to making final decisions on approach.</p>

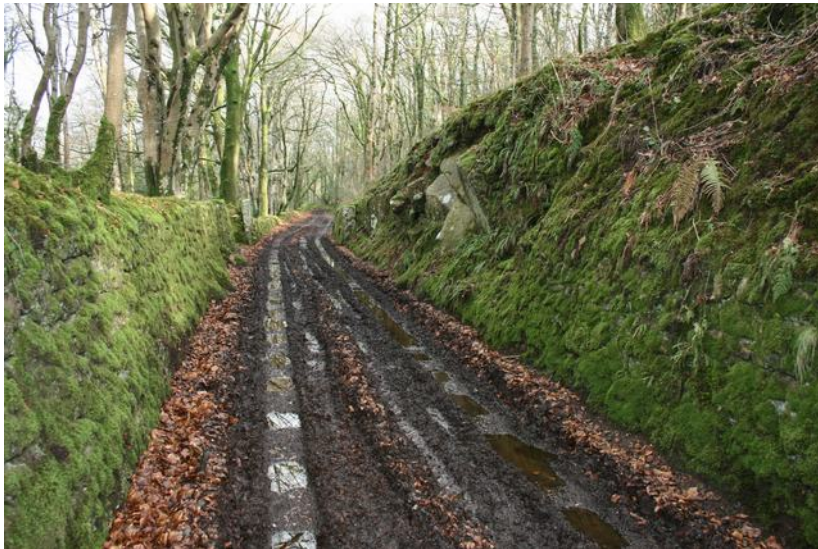
URS Ref: 20	Asset: Colcerrow branch tramway

CAU Ref: T31			
<p>Description:</p> <p>The Colcerrow branch tramway follows a tight curve at the south east end of the viaduct. The tramway follows a route along the side of the hill in deep cutting with stone walls to each side. The stone hedges have a steep batter and comprise well coursed rubble stone.</p> <p>The discontinuous granite pads are clearly evident. Though the tramway is heavily rutted.</p>			<p>Conservation Approach:</p> <p>Vehicle use to be monitored. It may be appropriate to lay a substrate in order to support the granite setts and to prevent erosion and displacement.</p> <p>Water logging to be managed by means of drainage channels installed in a manner to safe guard heritage values.</p>
<p>Condition:</p> <p>The tramway is deeply rutted and partly buried by earth. The granite pads are at risk of being dislodged by vehicle use.</p>		<p>Significance: Moderate</p> <p>The tramway evidences Treffry's exploitation of other reserves beyond the valley whi ch he was able to connect to his tram system.</p>

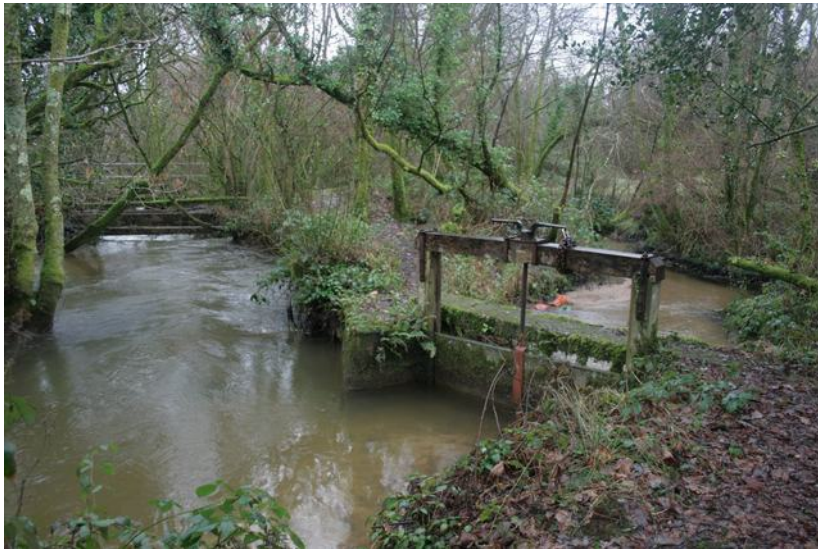
URS Ref: 21	Asset:

CAU Ref: L7/S	Carmears reservoir pool at Cam Bridges head sluice and feeder leat		
Description: Head sluice reservoir pool and feeder at Cam Bridges.			<p>Conservation Approach:</p> <p>The approach recommended within the survey report should be adopted to preserve water flow and heritage values including aesthetic value.</p>
Condition: A full survey is reported in the separate condition report.	Significance: Moderate The Carmears Leat was cut c1840 to provide power to the Carmears Incline and is therefore of significance to the heritage values of the valley.

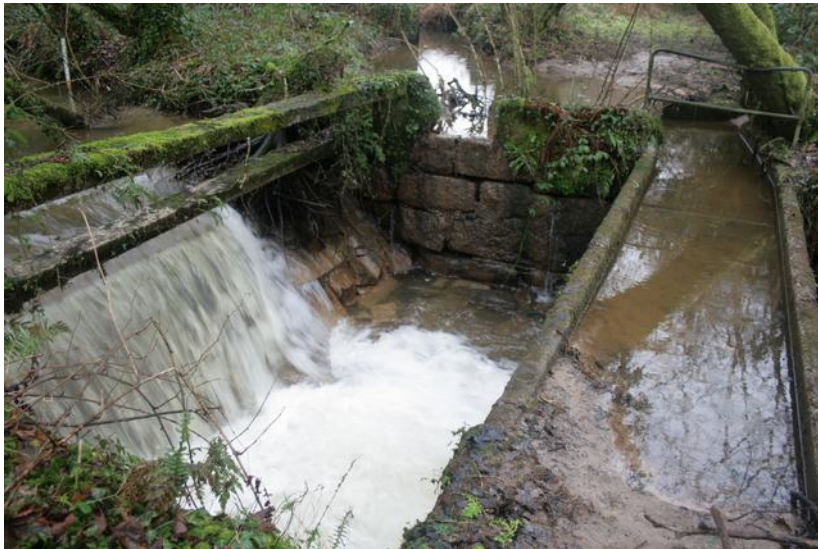
URS Ref: 22	Asset:

CAU Ref:	Carmears reservoir pool weir and overspill launder		
Description:			Conservation Approach:
Disused timber launder to take overspill water from the Carmears reservoir pool.			
Condition:		Significance: Low	The approach recommended within the survey report should be adopted to preserve water flow and heritage values including aesthetic value.
A full survey is reported in the separate condition report.		The launder and weir have intrinsic values but are of low significance to the heritage values of the valley.

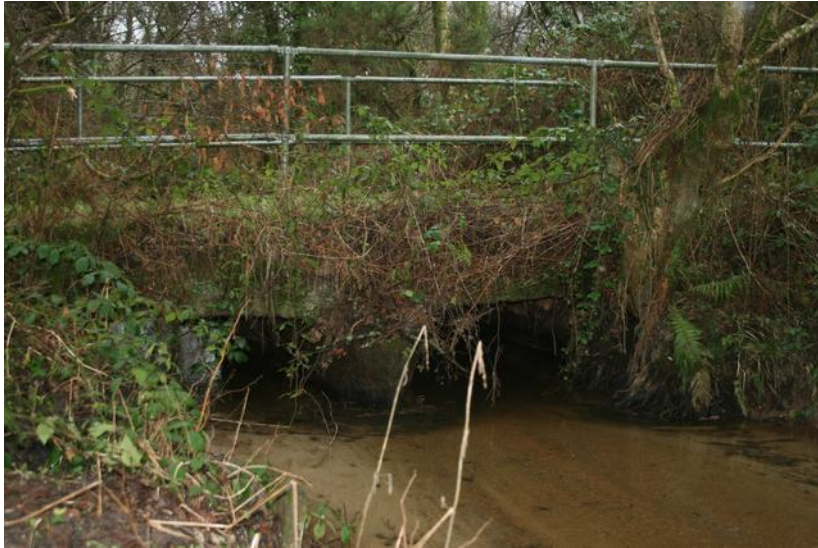
URS Ref: 23	Asset:

CAU Ref:	Carmears feeder leat Pathway over bridge		
Description:			
<p>A public path crosses in front of the Ca m Bridges reservoir pool and Carmears feeder leat. The bridge that carries the path over the leat is 2 arch structure of stone and may have been widened one arch being flat the other a broad segmental arch. There is no parapet and the railings on the bridge are modern.</p>		Conservation Approach:	
Condition:		The approach recommended within the survey report should be adopted to preserve water flow and heritage values including aesthetic value. Monitor and manage vegetation and ensure structural integrity.	
The bridge retains structural integrity but is becoming overgrown.		The bridge does not have significance to other heritage values within the valley

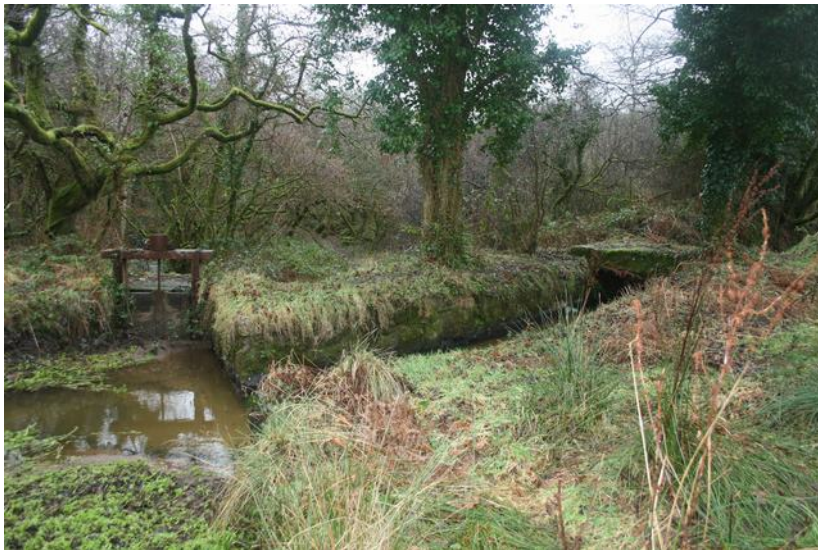
URS Ref: 24	Asset: Carmears return sluice feeder leat and bridge

CAU Ref:				
Description:		Conservation Approach:		
<p>Return sluice used to control the flow of water into the Carmears Leat system from the feeder leat. The feeder leat is a broad channel that feeds in to the narrower engineered Carmears Leat. The sluice returns the overspill water back to the river.</p> <p>The Carmears Leat passes through the area of woodland and quarries towards the Charlestown Leat reservoir.</p> <p>The reservoir is a granite structure now disused and was the means by which the water flow into both the Charlestown and Carmears Leats was controlled and managed.</p> <p>The line of the Carmears Leat continues to the Treffry Viaduct. The Charlestown Leat takes a higher course to cut across the front of the viaduct.</p>				<p>The approach recommended within the survey report should be adopted to preserve water flow and heritage values including aesthetic value.</p>

Condition:	Significance: Moderate			
A full survey is reported in the separate condition report.	The reservoir, sluices and other engineering works demonstrate the engineering requirements necessary to establish a leat system.

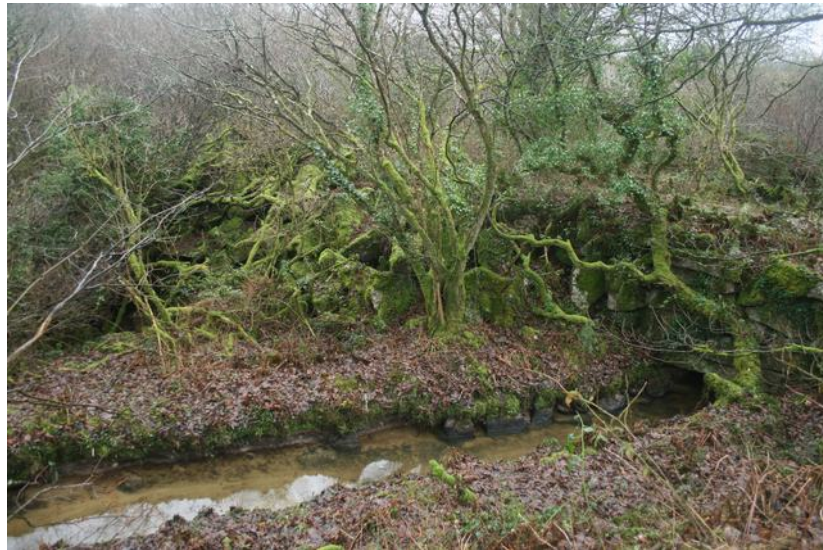
URS Ref: 25	Asset: Carmears Leat and bridge at Cam Bridges quarry

CAU Ref: L7/2			
Description: The Carmears Leat traverses across the site of the Cam Bridges quarry. It is bridged in several places by flat arched granite stone structures some more substantial than others. The Leat is well built and stone faced and in this location runs freely as it approaches the viaduct the edges of the leat become more obscured and silted.		Conservation Approach: The approach recommended within the survey report should be adopted to preserve water flow and heritage values including aesthetic value.	
Condition: A full survey is reported in the separate condition report.	Significance: Low The bridges over the leat are not in themselves of significance to the heritage values of the valley. They are however of intrinsic value and as a group contribute to the asset that is the Carmears Leat.

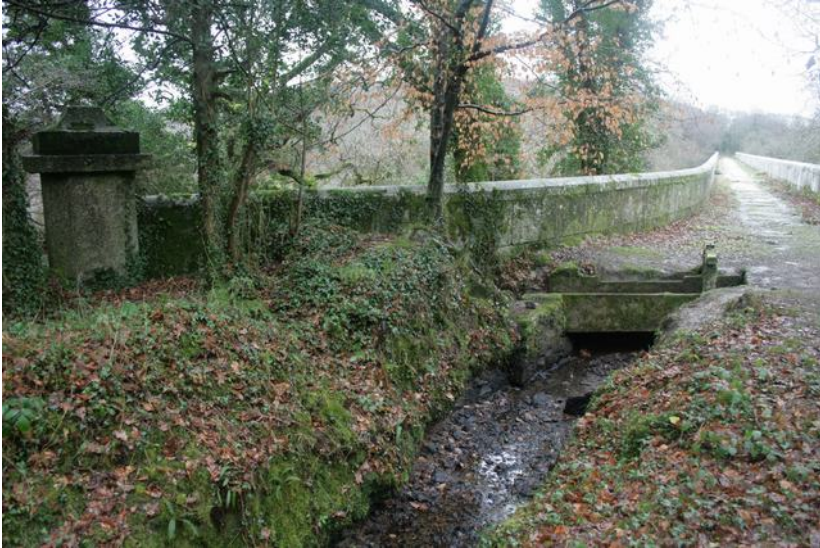
URS Ref: 26	Asset:

CAU Ref: L5/1	Carmears aqueduct and Chastletown launder		
<p>Description:</p> <p>As the Carmears Leat approaches the viaduct it is crossed by the timber launder that carries the Charlestown Leat across the face of the viaduct and along the west side of the valley.</p> <p>The Carmears Leat is carried across the viaduct in a channel beneath the tramway sleepers.</p>			<p>Conservation Approach:</p> <p>The approach recommended within the survey report should be adopted to preserve water flow and heritage values including aesthetic value.</p>
<p>Condition:</p> <p>A full survey is reported in the separate condition report.</p>		<p>Significance: Moderate to High</p> <p>The Carmears Leat and Treffry aqueduct are significant features of the valley. The dual use of the viaduct as both aqueduct and tramway contributes to its architectural and engineering interest.</p>

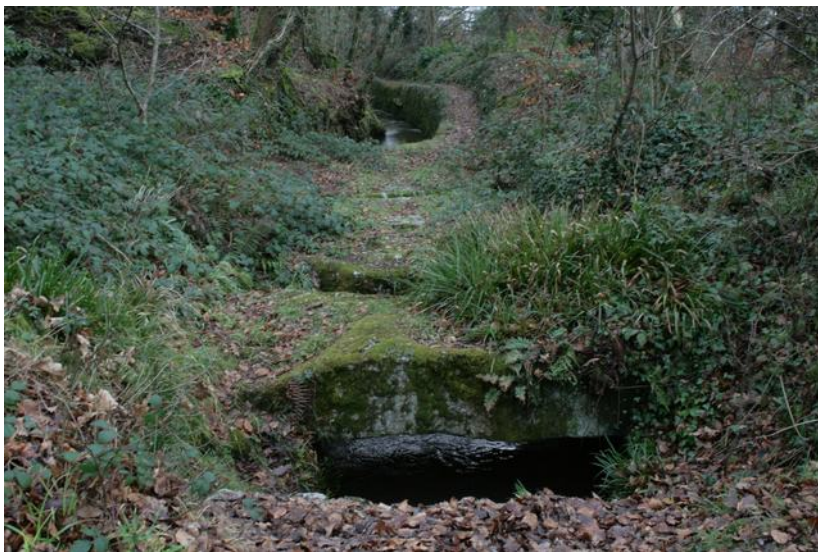
CAU Ref:	Carmears leat in culvert		
<p>Description:</p> <p>On crossing the viaduct the Carmears Leat remains initially in culvert. The leat is capped by substantial single granite cap stones which are slightly arched.</p> <p>In this location the leat has broad berms to each side and on its north side there is a stone wall atop the bank that overlooks the leat.</p>			<p>Conservation Approach:</p> <p>The approach recommended within the survey report should be adopted to preserve water flow and heritage values including aesthetic value.</p>
<p>Condition:</p> <p>A full survey is reported in the separate condition report.</p>		<p>Significance: Moderate</p> <p>The Carmears Leat contributes to the significance of the valley. The open culvert is an unusual treatment not evident elsewhere and its purpose is unclear.</p>

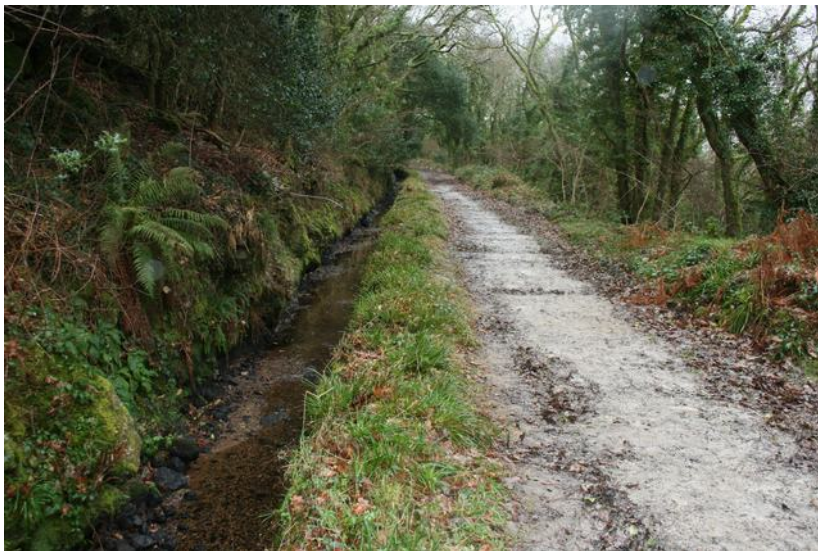
CAU Ref: L7			
Description: On crossing the Treffry viaduct the Carmears leat runs alongside the Tram way. The tramway crosses the Leat in a number of places by means of simple bridges.		Conservation Approach: The approach recommended within the survey report should be adopted to preserve water flow and heritage values including aesthetic value.	
Condition: A full survey is reported in the separate condition report.	Significance: High

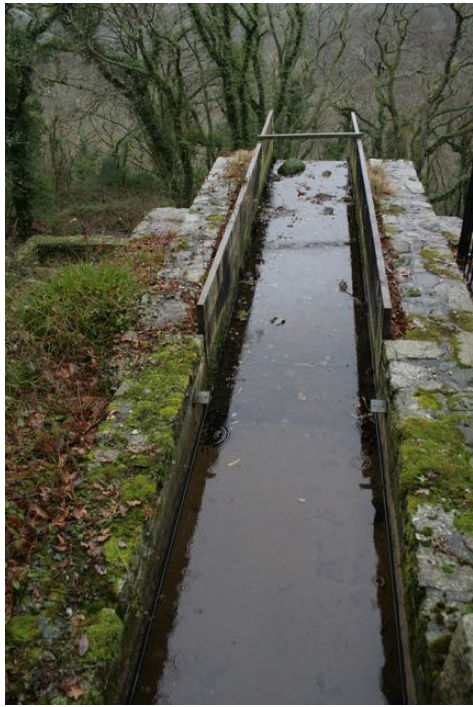
CAU Ref:	Carmears Leat launder		
<p>Description:</p> <p>The Carmears Leat powered the overshot wheel that first used to power the Carmears Incline and subsequently modified to drive the china stone mills.</p> <p>The existing timber launder probably represents a more recent replacement or modification following disuse of the china stone mills. The launder is now used to provide a picturesque waterfall.</p> <p>The stone channel which holds the launder is likely to be original and could date to the 1840s.</p>			
<p>Condition:</p> <p>Good</p>			<p>Conservation Approach:</p> <p>Maintain to ensure a good flow of water.</p>
<p>Significance: Low</p> <p>The launder in its present condition is probably not historic.</p>

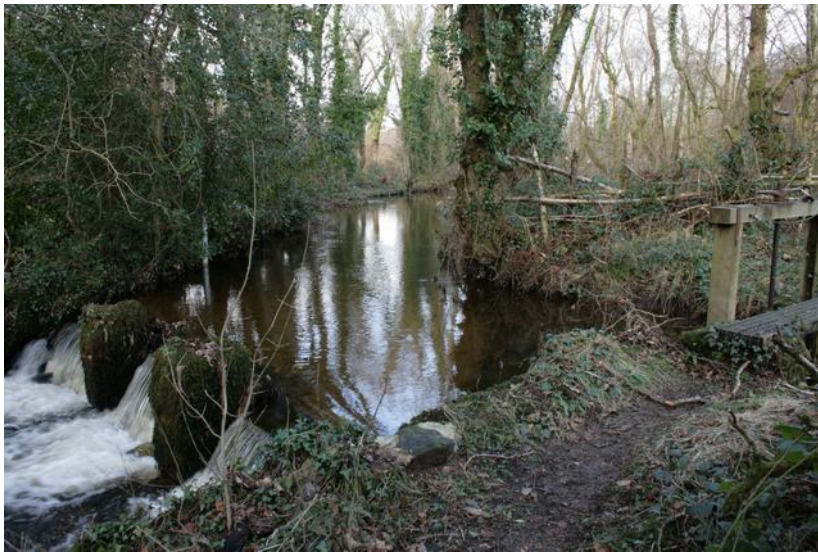
CAU Ref: L6/S			
Description: The Fowey Consols Leat was engineered in the 1820s. It takes its water from the River Par at Gatty's Bridge. The river has been slightly modified to provide both a turn out towards the leat and seems to have been embanked to create a reservoir pool. The flow of the River Par is maintained by means of a weir comprising a series of rocks laid across the river. The flow of water into the leat is controlled by means of a sluice.			
Condition: Good			
Conservation Approach: The approach recommended within the survey report should be adopted to preserve water flow and heritage values including aesthetic value.
