Luxulyan Valley

Conservation Management Plan - Gazetteer

Cornwall Heritage
Trust

July 2011 - Rev.03

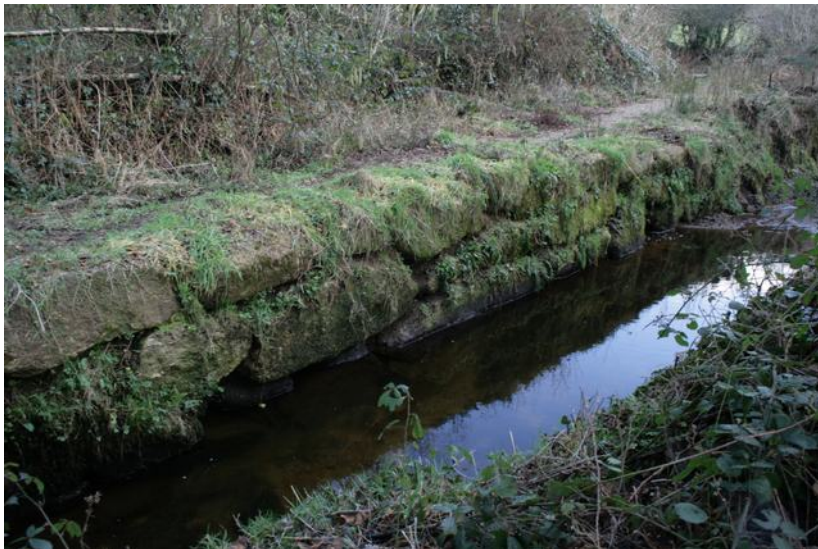
CAU Ref: L6/S				
Description: The Leat channel is broad and shallow and is lined with large rough coursed stone blocks.				
Condition: The structure of the Leat in this location appears sound but refer to the condition survey report for detailed assessment.		Significance: High The Fowey Consols Leat was one of the first engineering structures to be built within the valley. It retains particularly good evidential value in its fabric at this point as well as a general aesthetic.		
Conservation Approach: The approach recommended within the survey report should be adopted to preserve water flow and heritage values including aesthetic value.

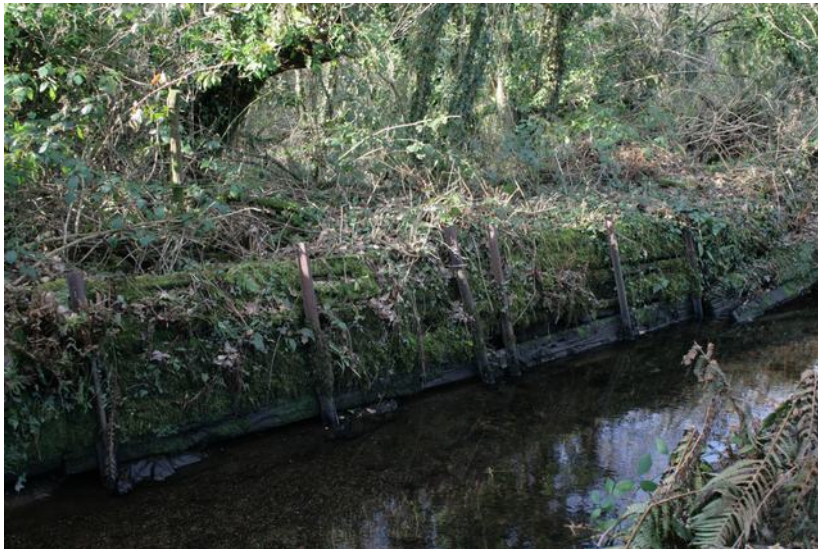
CAU Ref:		
<p>Description:</p> <p>The Fowey Consols Leat runs alongside the public highway for much of its length. Initially it was lined with stone but large parts of it show evidence of timber revetment comprising posts set to the front of horizontal planks.</p> <p>It is not known whether this is an original feature of the leat or a phase of later strengthening of the sides.</p>		
Condition:	Significance: Moderate to High	<p>Conservation Approach:</p> <p>The approach recommended within the survey report should be adopted to preserve water flow and heritage values including aesthetic value.</p>
Refer to detailed survey undertaken as part of the condition report. This part of the leat is becoming overgrown with vegetation encroaching upon the bank.

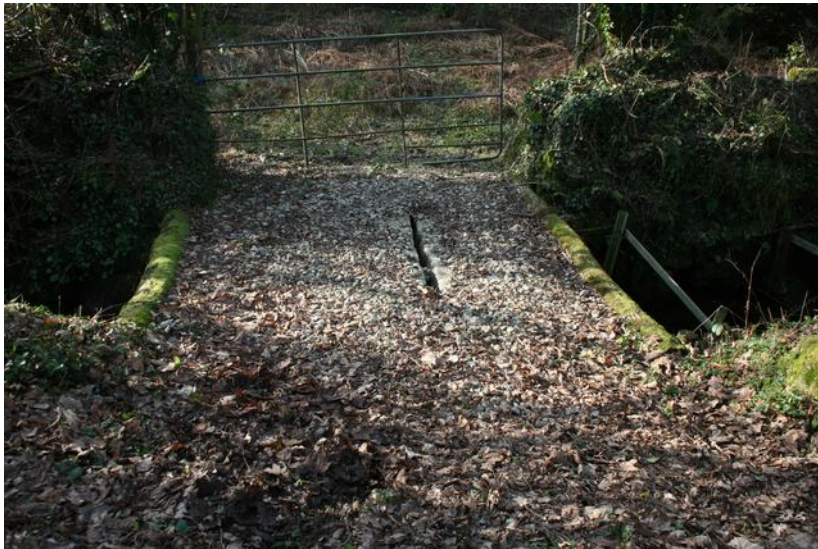
CAU Ref:			
Description: A field access track bridges the leat and comprises large individual granite stone sleepers.			Conservation Approach: The structural integrity of the bridge needs to be determined and its load capacity demonstrated. A weight restriction should be imposed so to preserve the structural integrity of the asset.
Condition: Good	Significance: Low

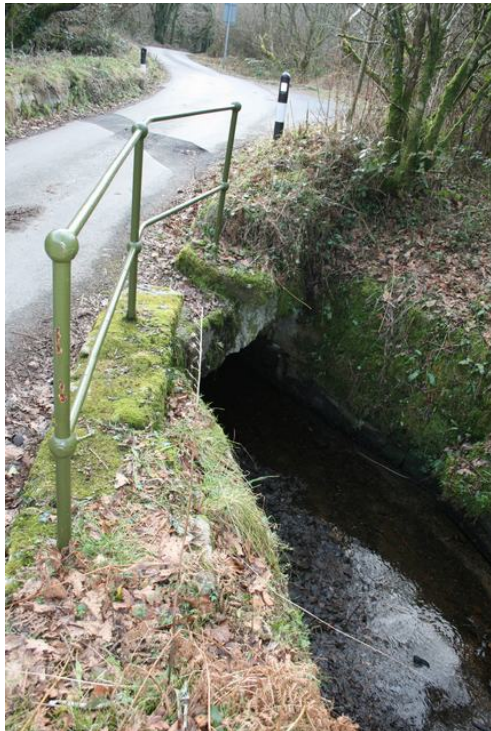
CAU Ref:	Fowey Consols road bridge		
Description:			<p>Conservation Approach:</p> <p>The load bearing capacity of the bridge needs to be determined and an appropriate weight restriction imposed so to ensure structural integrity.</p>
Single span flat arched road over-bridge with low parapet and modern iron railings.			
Condition:	Significance: Low		
Good

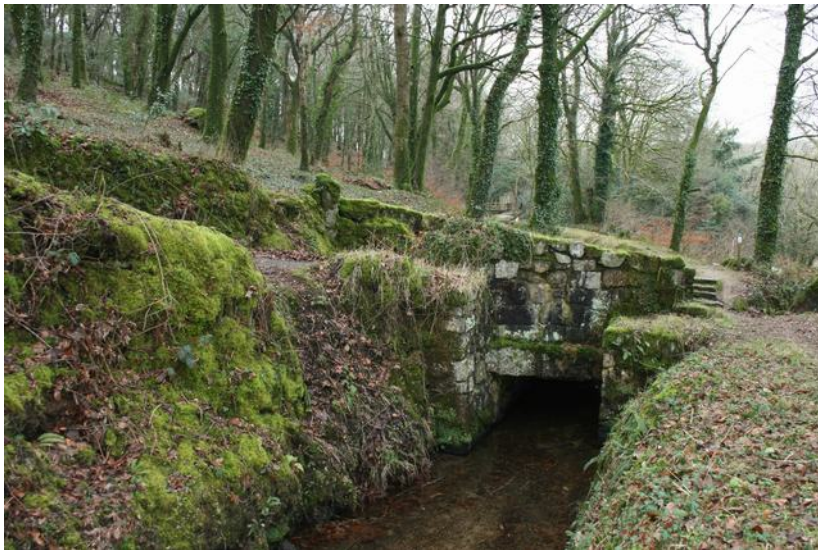
CAU Ref:			
Description: The public road up the Colcerrow Valley is carried over the leat by means of a flat arched single span bridge with a raised parapet and abutments. Steps are constructed on its road face to give access to the path that runs alongside the leat towards the viaduct.		Conservation Approach: The load bearing capacity of the bridge needs to be determined and an appropriate weight restriction imposed so to retain structural integrity.	
Condition: Good but partly overgrown.	Significance: Moderate The bridge is well engineered and contributes to the values of the leat overall.

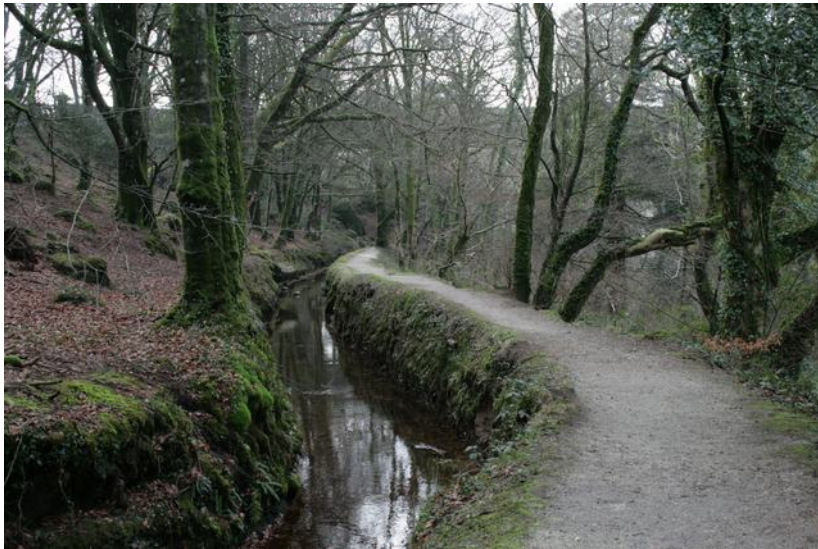
CAU Ref:	Fowey Consols approach to viaduct		
Description:			Conservation Approach:
<p>On its approach to the viaduct the leat follows the contours of the valley and is carried slightly above the level of the Luxulyan Valley public highway.</p> <p>The leat follows a slightly sinuous course and at this point is both narrow and deep with stone lined banks.</p> <p>The approach to the viaduct is particularly picturesque and at this location the leat is also at a level slightly above the Velvet Path which runs alongside the public highway before turning east up the Colcerrow Valley.</p>			
Condition:		Significance: High	The approach recommended within the survey report should be adopted to preserve water flow and heritage values including aesthetic value.
See detailed survey report		This is a location of high aesthetic value of significance to the valley.

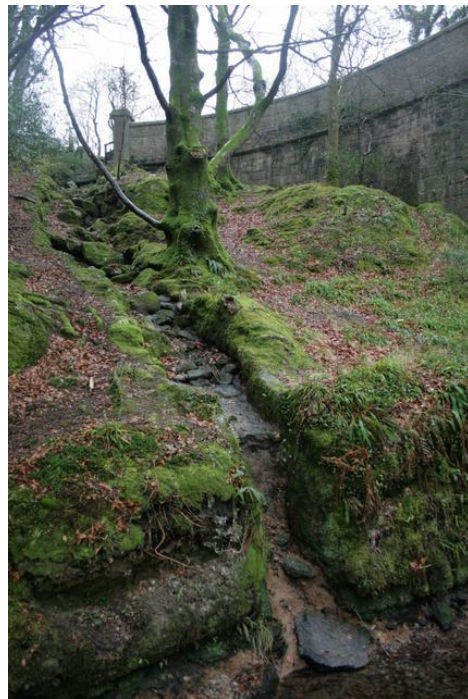
CAU Ref:	Carmears Leat overflow sluice		
Description:			<p>Conservation Approach:</p> <p>The approach recommended within the survey report should be adopted to preserve water flow and heritage values including aesthetic value.</p>
An overspill sluice for the Carmears Leat is located where the leat emerges from the viaduct. The overspill is fed down the hillside to the Fowey Consols at the lower level.			
Condition:		Significance: Low	
Good

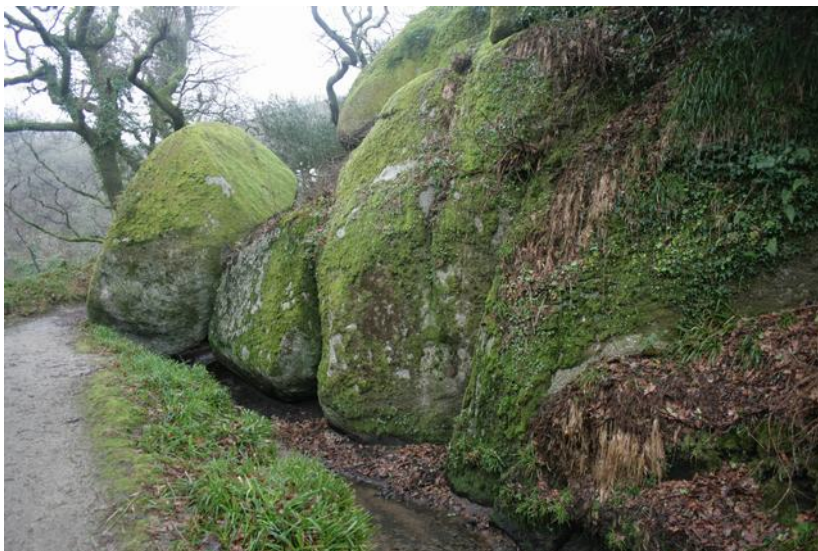
CAU Ref: L6/2				
<p>Description:</p> <p>As the leat passes beneath the viaduct it is excavated beneath a natural rock outcrop.</p>				
Condition:		Significance: Moderate to high This feature contributes to the aesthetic values of the valley and is part of the RIGS designation.		
<p>Conservation Approach:</p> <p>Adopt the conservation approach recommended for conservation of natural assets. Manage vegetation to ensure good visibility of the feature.</p>

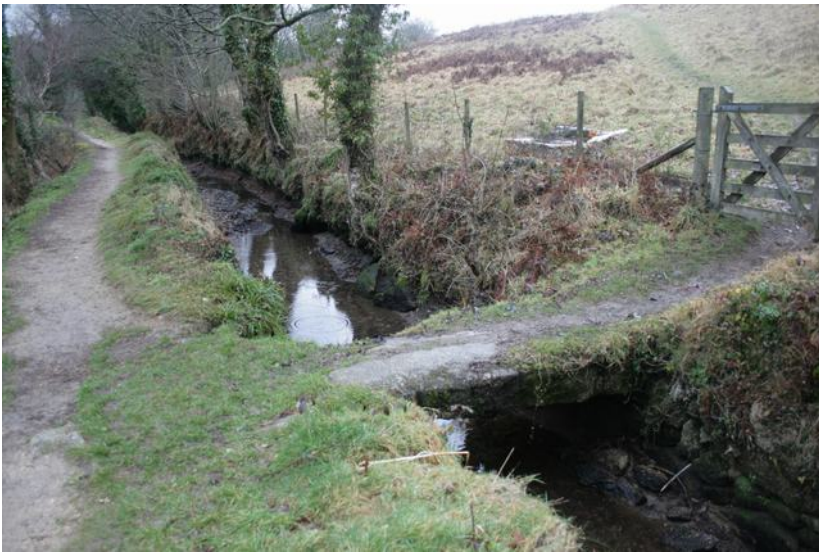
CAU Ref:			
Description: Simple granite slab field bridge.			<p>Conservation Approach:</p> <p>If vehicular access is required the load bearing capacity of the bridge needs to be determined and a weight limit imposed so to ensure structural integrity.</p>
Condition: Good	Significance: Low

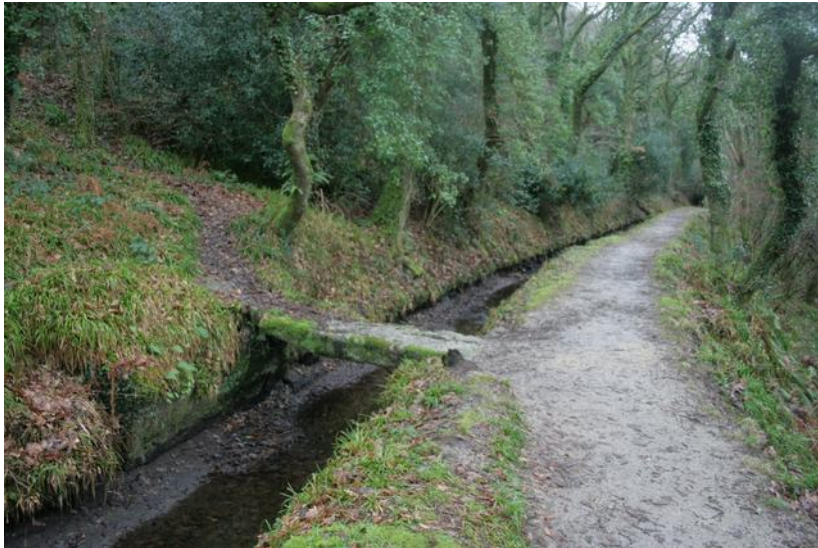
CAU Ref:			
Description: Simple granite slab field bridge.			Conservation Approach: Monitor condition
Condition: Good	Significance: Low

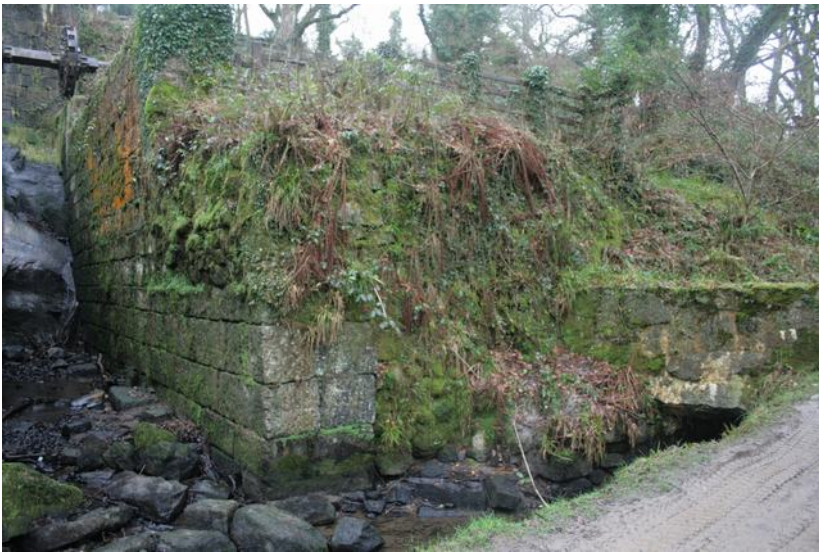
CAU Ref: L6/3			
<p>Description:</p> <p>The Fowey Consols leat passes alongside the Carmears wheel pit and receives the discharge from the overshot wheel. The leat is carried beneath a bridge in front of the remains of parts of the Wheelpit Mill.</p> <p>The bridge is a well engineered granite structure and appears to be contemporary with the Wheelpit china clay mill of the 1890s.</p>			<p>Conservation Approach:</p> <p>Monitor. Management decisions to be made following detailed survey</p>
<p>Condition:</p> <p>Good</p>	<p>Significance: High</p> <p>Provides good aesthetic values that contribute to the significance of the valley</p>

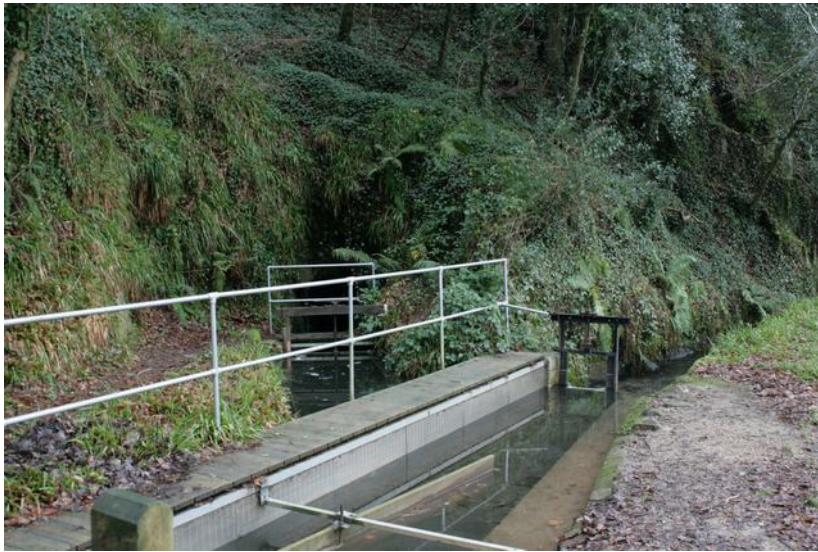
CAU Ref: L6/5			
Description: The Fowey Consols leat originally passed across the face of the Carmears rocks in a timber aqueduct. This was replaced in the 1940s by the present bored tunnel. Flow to the tunnel is controlled and the leat continues for a short distance beyond the tunnel before it is discharged in open channel down the hillside.			
Condition: The leat and sluices have been modified in recent times.		Significance: Moderate to Low The original character of the leat has been modified. The timber aqueduct was a renowned local feature and feat of engineering but has been lost.	
Conservation Approach: The approach recommended within the survey report should be adopted to preserve water flow and heritage values including aesthetic value. Consideration should be given to the proposal to divert some water flow to re-create the Carmears waterfall.

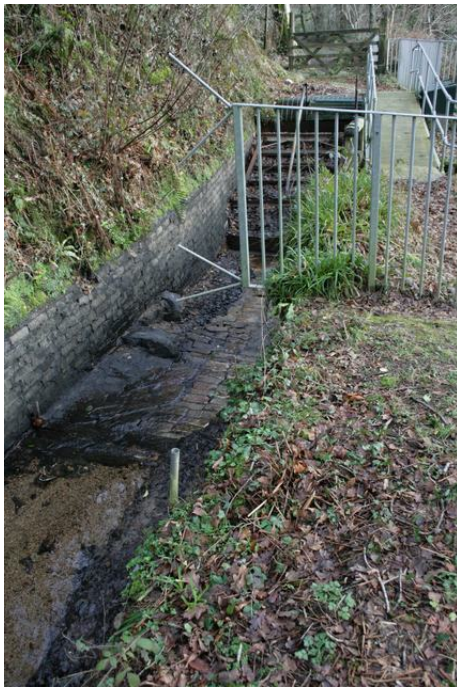
CAU Ref: L6/7	Fowey Consols cut off		
<p>Description:</p> <p>The Fowey Consols Leat was truncated and diverted into pipes and taken down the hillside to power the china stone mills that were being established at Pons Mill during the 1870s.</p> <p>The cut off is stone lined and controlled by sluices and has evidently been modified in recent times. The water flow is still carried in pipes but is now used to power the community turbines.</p>			
<p>Condition:</p> <p>Good</p>		<p>Significance: Low</p> <p>The cut off has general evidential value in association with the china stone mills at Pons Mill but is not of intrinsic significance.</p>	<p>Conservation Approach:</p> <p>Manage to conserve flow in accordance with the survey report.</p>

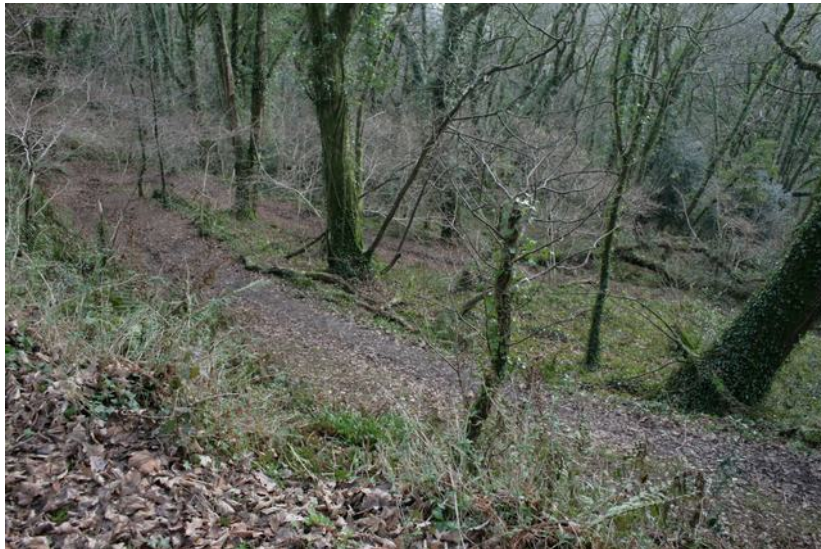
CAU Ref: V7, V8	Velvet Path up to Carmears		
Description:		<p>Conservation Approach:</p> <p>Maintain the footpath in good order</p>	
<p>The Velvet Path was built by Nicholas Kendall between 1840 and 1870. The path takes a circuitous route through the valley and ascends to the summit at Carmears by a series of hairpins terraced into the hillside.</p>			
Condition:	Significance: High		
<p>The path is still well defined. There is no evidence as to whether the path was originally metalled or not but this is likely</p>	<p>The path evidences the picturesque aspirations of Kendall in showing the works of Trefry. The path has good historic and aesthetic values and perambulates around the valley.</p>

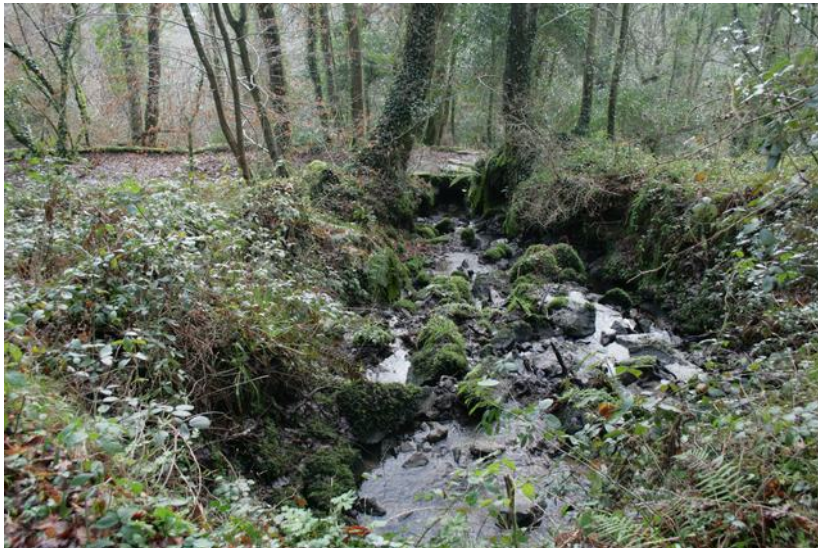
CAU Ref:			
<p>Description:</p> <p>As the path ascends to Carmears it bridges the open channel that carried overspill water from the Fowey Consols as it passed in front of Carmears Rocks. Kendall engineered the overspill so to create an artificial waterfall which could be 'turned on' when required. The channel is bridged by a series of single granite flat slabs.</p>			
<p>Condition:</p> <p>Good</p>		<p>Significance: Moderate</p> <p>The waterfall was engineered to provide picturesque value to the drive. The asset has good aesthetic values that contribute to the picturesque significance of the valley.</p>	<p>Conservation Approach:</p> <p>Manage to maintain water flow</p>

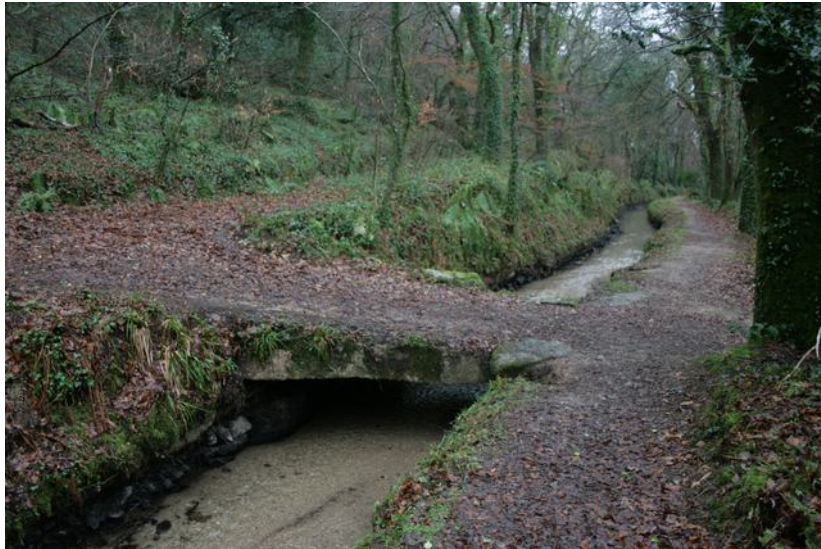
CAU Ref:			
Description: As the Velvet path descends from Carmears it crosses the Fowey Consols Leat by means of a granite slab bridge.			Conservation Approach: Monitor condition
Condition: Bridge in good condition	Significance: Low Bridge of simple construction which evidences the engineering of the path.

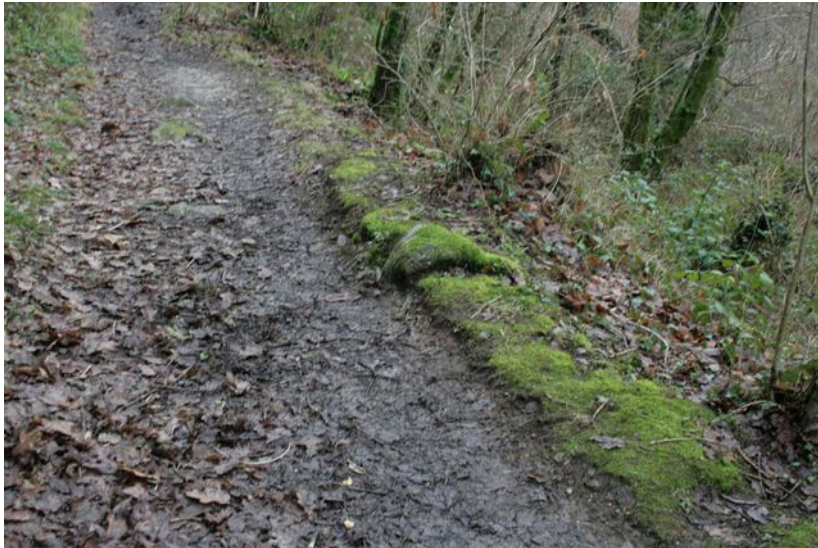
CAU Ref: V11, V13	Velvet Path lower ride		
Description:			<p>Conservation Approach:</p> <p>Monitor condition. Consider reinforcing the substrate to prevent erosion and water logging.</p>
<p>Beyond its crossing of the Carmears Incline the pathway becomes less well kept and is less well defined having been encroached by vegetation. The path way is terraced into the hillside and In places there is evidence of stones set as a kerb against the hillside.</p>			
Condition:		Significance: Low	
The pathway is generally eroded, waterlogged and sometimes difficult of access

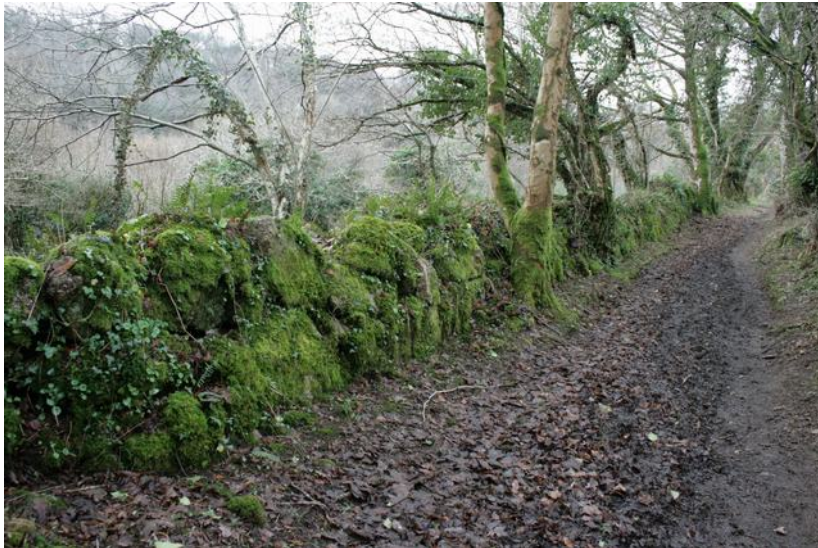
CAU Ref: V14			
Description: As the path approaches the viaduct it runs partly alongside and above the public road. In this location the pathway is contained by a stone hedge.		Conservation Approach: Monitor condition	
Condition: Partly overgrown with evidence of surface erosion.	Significance: Low to Moderate

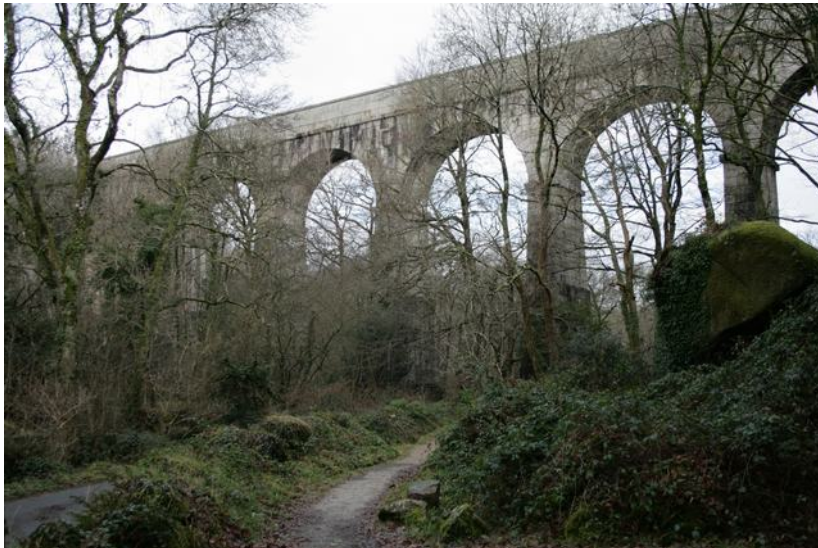
CAU Ref: V15			
<p>Description:</p> <p>As it approaches the viaduct the Velvet Path runs alongside the public road and passes beneath the viaduct.</p> <p>This is a particularly significant view which has picturesque qualities and was enabled to appreciate the scale and engineering achievement of the viaduct.</p>			
Condition:		<p>Significance: High</p> <p>This aspect of the path has considerable aesthetic value and evidences the picturesque nature of the ride.</p>	<p>Conservation Approach:</p> <p>This view is one of the more significant in the valley. Any conservation works or other work programmes, highway works or bridge repairs should take proper consideration of this view point.</p> <p>Tree felling to be considered to ensure that the prominence of the viaduct in the view is retained</p>

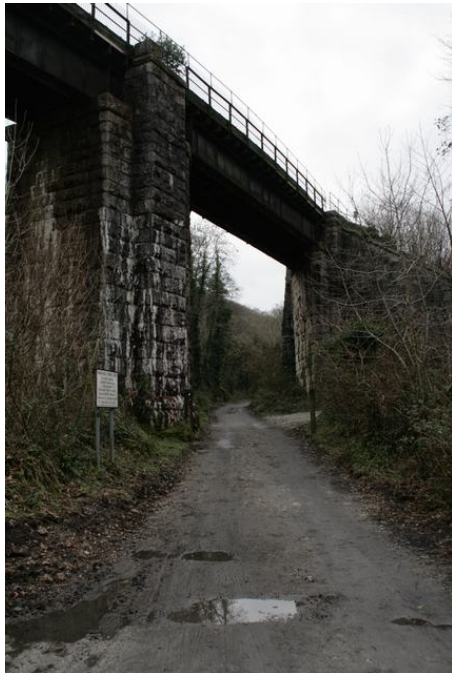
CAU Ref: T42		
<p>Description:</p> <p>The Tramway traverses along the valley floor. From the foot of the Carmears Incline the tramway runs beneath the CMR viaduct bridge.</p> <p>This part of the tramway retains no surface evidence for sleepers or other features. This part of the tramway was utilised and probably modified as part of the later tram way that was taken to the Trevanney Dry. It is unlikely that evidence for the earlier tramway has been preserved.</p>		
Condition:	Significance: Low	Conservation Approach:
The alignment of the tramway is generally well preserved and readily identifiable	The tramway has lost some evidential values. It retains a general historic value evidencing transport infrastructure through the valley.	Monitor condition.

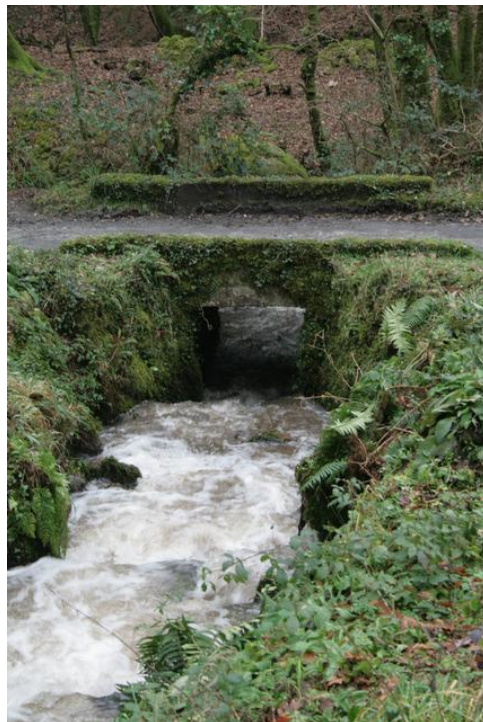
CAU Ref:	Bridge over waterfall outflow		
Description:			Conservation Approach:
<p>The tramway passes alongside the Cornwall Minerals Railway and it bridges an outfall overflow channel from Fowey Consols. The outfall is culverted beneath the CMR to join the River Par.</p> <p>The small flat arched bridge has a slightly raised stone parapet</p>			
Condition:	Significance: Low		Monitor condition
The bridge appears in good condition	Part of the Rock Mills Tramway group of monuments that collectively have aesthetic value.

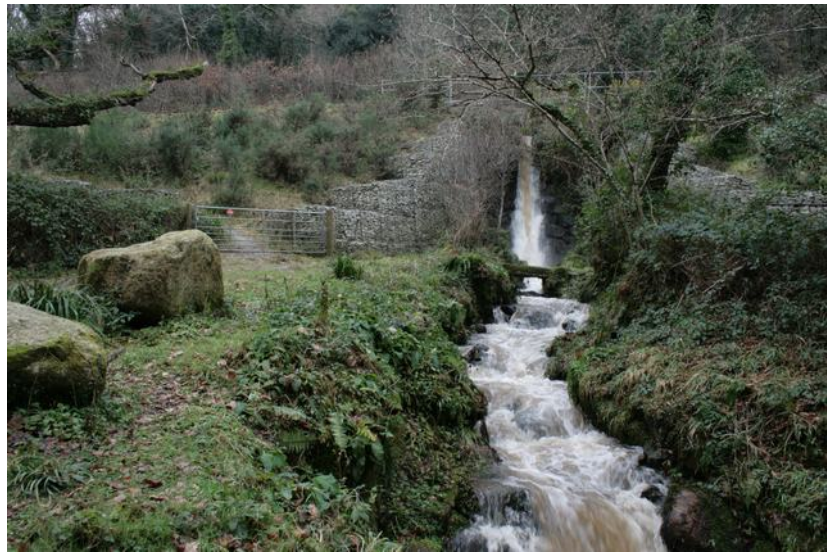
CAU Ref:			
<p>Description:</p> <p>The overspill channel from Fowey Consols is routed down the valley sides, it runs alongside the Carmears incline before passing beneath it. The channel is in culvert beneath the CMR and issues in a waterfall down the railway embankment. To join the River par.</p> <p>A single stone bridge carries a farm track over the outfall. The farm bridge is of simple slab construction and together with the tram line bridge forms a picturesque group.</p>		<p>Conservation Approach:</p> <p>Monitor condition</p>	
<p>Condition:</p> <p>Good</p>	<p>Significance: Low</p> <p>The stream, bridge and railway have good aesthetic value and form part of the group of monuments that define the Rock Mill Tramway.</p>

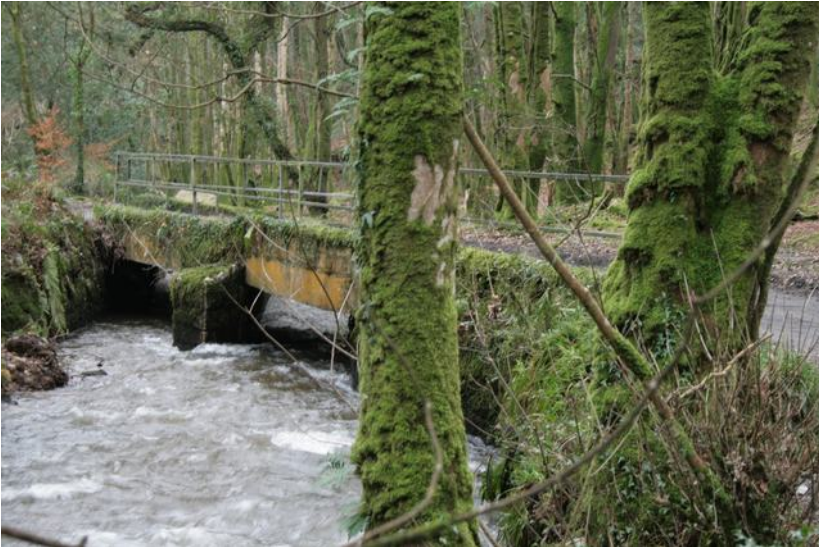
CAU Ref: T43			
<p>Description:</p> <p>The original line of the Rock Mills tramway is truncated at a point close to the crossing of the river Par. The original tramway continued on the east side of the river and is denoted by a slight hollow way.</p> <p>The tramway was diverted in the early 20th century to cross the river on the approaches to the Trevanney Dry. The river bridge is a double span structure with a low parapet and appears in part to be built of concrete.</p>			<p>Conservation Approach:</p> <p>Monitor condition. If the bridge is used for vehicular traffic the load bearing capacity needs to be determined.</p>
<p>Condition:</p> <p>The bridge appears to be in good condition</p>	<p>Significance: Low</p> <p>Part of a group of monuments that comprise the Rock Mill Tramway. The group has historical and evidential values</p>

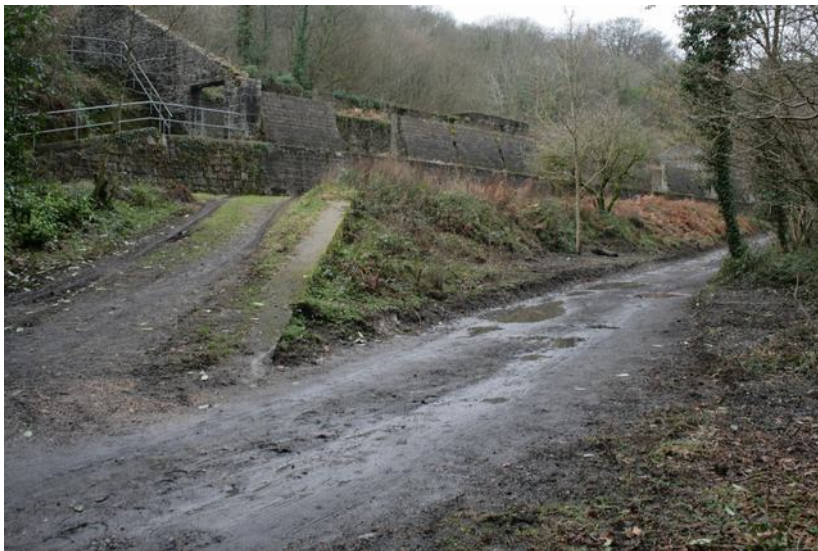
CAU Ref: T55			
Description: The tramway was diverted in the early 20 th century to service the Trevanney Dry china clay works. The new tramway diversion passes to the front of the Trevanney works with inclines at each end to access a loading platform built against the east side of the works. This tramway inclines have stone kerbs and a tarmac surface. The tramway extends slightly beyond the building where there is some evidence for a small railhead. .			
Condition: The incline is in a poor condition and partly overgrown		Significance: Low Provides historical and evidential values for the continued utilisation of the tramway following the construction of the works during the 1920s	
			Conservation Approach: Monitor and treat as part of the overall conservation of the Trevanney works.

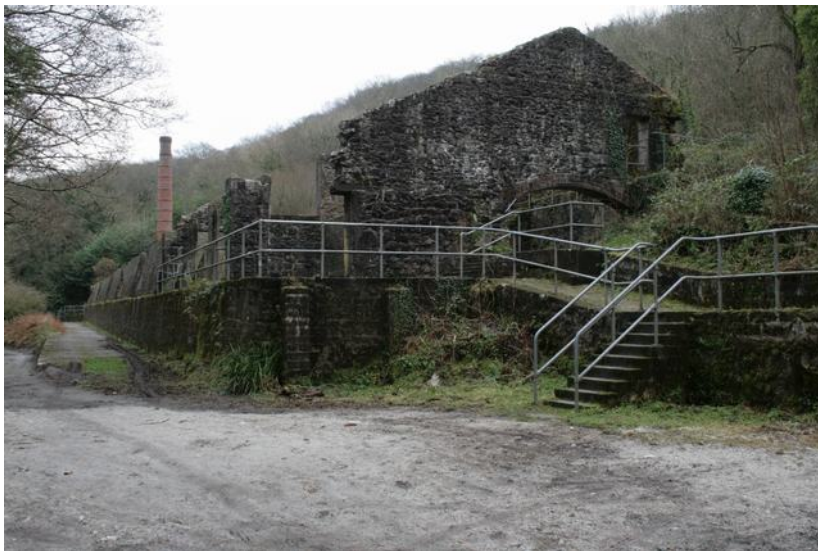
CAU Ref: C2	Central Cornwall Dry known also as the Trevanney Dry		
Description:			<p>Conservation Approach:</p> <p>A full historic building record and building condition survey is recommended prior to formulation of any management decisions. The site is known for its bat roosts and these are statutorily protected. Other ecological assets are also recorded.</p> <p>Replacement railings would be more sympathetic to the historic character of the building and there is generally an opportunity for works that would enhance and better reveal the significance of the asset.</p>
<p>Single storey granite built coal fire d pan kiln with later exten sions and modifications carried out in concrete.</p> <p>The cylindrical brick chimney is at the southern gable end, the furnace with fire doors is at the northern end. .</p> <p>The drying pans are located at the front of the building and the settling t anks are arranged to the rea r. An access or l oading platform extend s along the fro nt of the building and was serviced by the tramway.</p> <p>The building is in a roofless con dition and access and wal kways are provided with utilitarian steel tube railing.</p>

Condition:	Significance: Moderate		
Consolidated as a roofless ruin. T he settling tanks are mostly flooded and not accessible.	The Trevanney Dry represents renewed exploitation of the valley as it embraced the opportunities offered by the china clay industry. The building is typical of its type and of significance to the values of the valley.

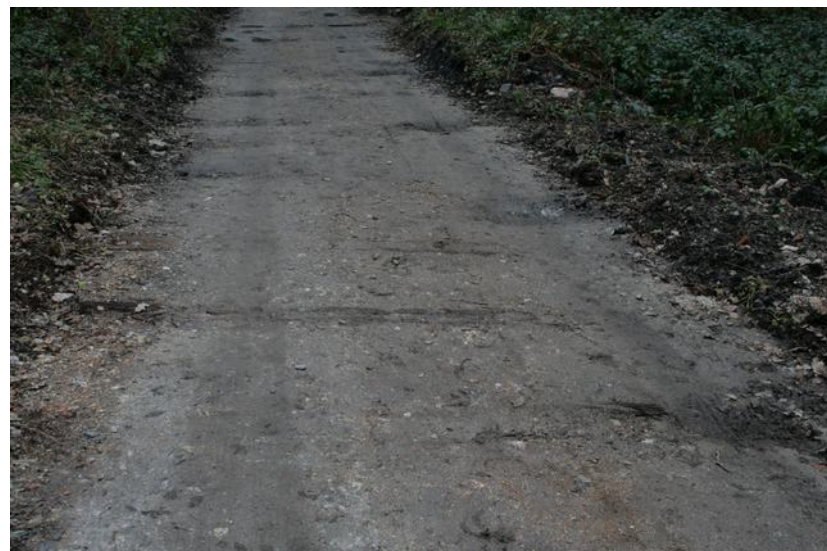
CAU Ref:			
<p>Description:</p> <p>The diverted Rock Mill Tramway, built in 1920 retains some evidence for timber sleepers.</p>		<p>Conservation Approach:</p> <p>Monitor condition and evaluate to determine vulnerability to erosion and degradation.</p>

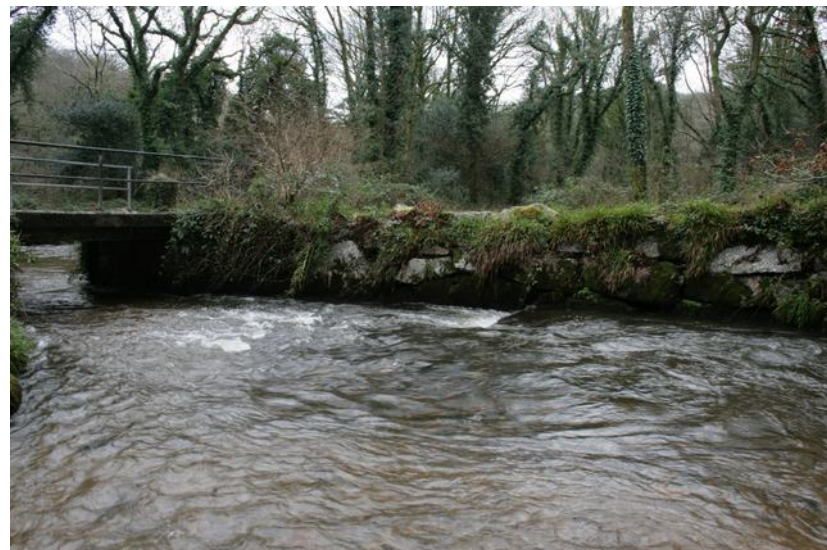
CAU Ref:	Rail bridge over the River Par		
Description:			<p>Conservation Approach:</p> <p>Monitor condition and structural integrity</p>
<p>The bridge is flat arched and of stone and concrete construction and dates to the 1920s. It has modern tubular railing.</p> <p>The river approaches the bridge at an acute angle and the banks have been strengthened with stone presumably to prevent erosion of the bridge abutments.</p>			
Condition:	Significance: Low		
Good	The structure is of 1920s date and relates to the diversion of the Rock Mill tramway

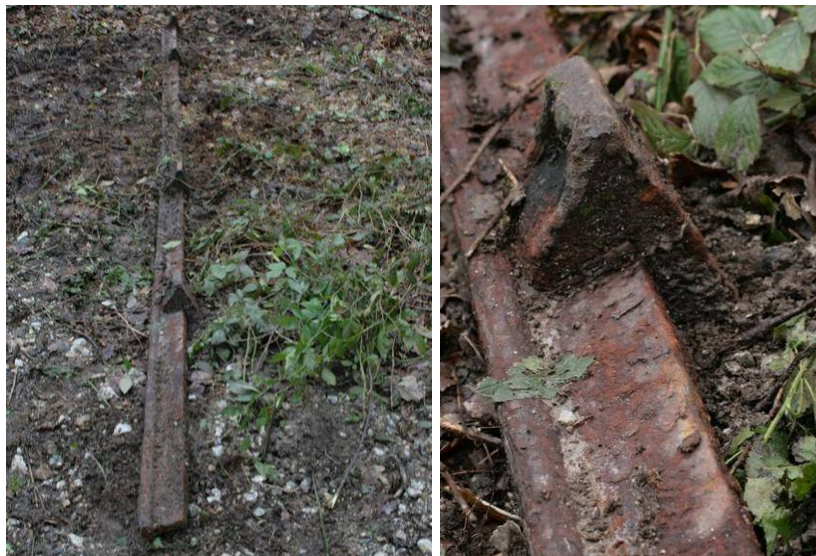
CAU Ref:	Length of rail		
Description:			
<p>Approx 4m length of iron tram rail. The piece is in T section and retains a number of chair settings that are fixed by means of iron wedges.</p> <p>The rail is comparable to CAU type C and chair design type G. (CAU report Fig 18)</p>			
Condition:		Significance: Moderate to High	Conservation Approach:
Good		<p>A chronology for rail types has not been developed. Existing rail is rare within the valley and this example provides good evidential value</p>	
			<p>This is a portable artefact that is at risk of loss (but unlikely to be removed). The CAU report of 1988 identified a number of similar artefacts but none of these could be located during the site visit of 2011.</p> <p>Consideration should be given for retrieval of all portable artefacts at risk.</p>

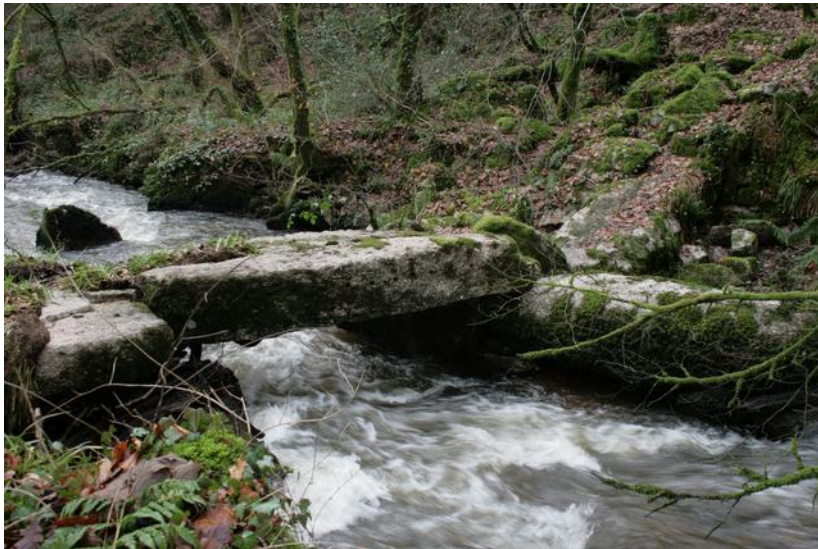
CAU Ref: T46 T47	Tram bridge over river and incline plane		
Description:			Conservation Approach: Monitor condition
Simple stone slab bridge that provides a crossing of the River Par, apparently associated with a stone incline (T47) that leads up the hillside to the Orchard Quarry. .			
Condition: Good		Significance: Moderate to Low

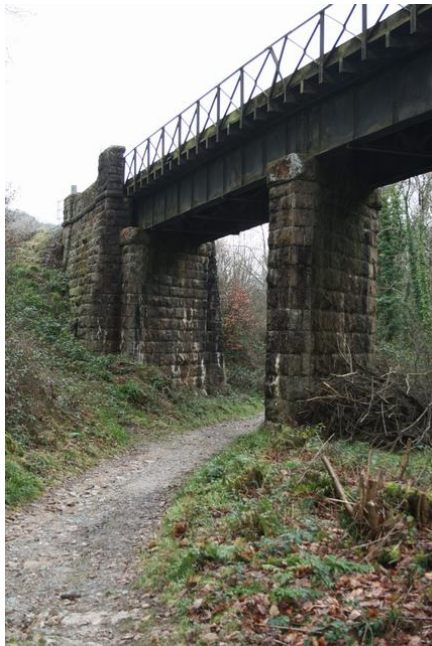
URS Ref: 60		Asset: Tramway beneath CMR

CAU Ref:				
<p>Description:</p> <p>The Rock Mill Tramway passes beneath the CMR. The CM R is carried on a stone and iron viaduct.</p>				
Condition:		Significance: Moderate to Low		<p>Conservation Approach:</p> <p>Monitor condition.</p>
Good		<p>This vantage point retains aesthetic value and provides a visual juxtaposition between the old tramway and the new railway that replaced it.</p>

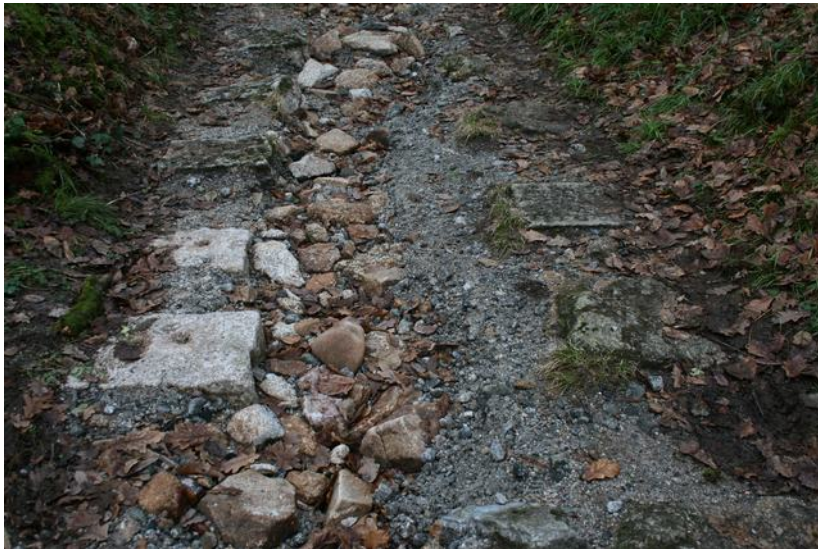
CAU Ref: T48			
<p>Description:</p> <p>Water running down the slope has caused erosion of the tramway and has exposed the granite setts and sub strata.</p>			<p>Conservation Approach:</p> <p>This part of the tramway is vulnerable to water erosion and additional degradation by off road users that use this pathway.</p> <p>The condition of the path needs constant monitoring. A programme of survey is recommended to determine survival or original features and thereby to form the basis of any future management proposals.</p>
Condition: Poor		Significance: Moderate to High

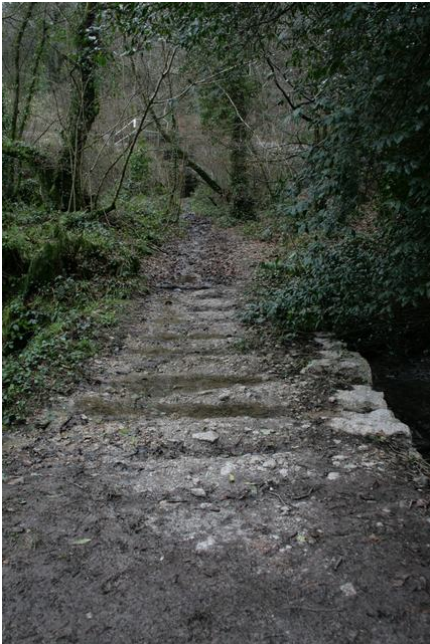
URS Ref: 62		Asset: Tramway stone bridge crossing the river

CAU Ref: T49				
Description: Granite bridge across the river formed of individual sleepers laid across the river. The granite sleepers retain evidence for chair fittings.			Conservation Approach: Monitor condition	
Condition: Good		Significance: Moderate to High

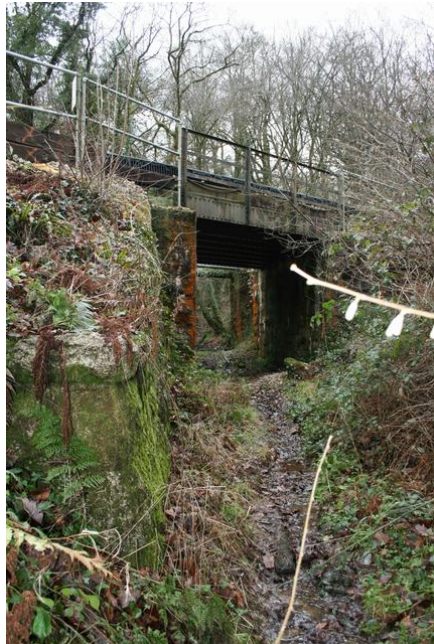
CAU Ref: T50	Tramway beneath rail bridge		
Description:			
<p>The tramway enters the Rock Mill Quarry in cutting with stone revetment. The CMR is carried on an iron over-bridge with stone abutments.</p> <p>Soil build up has apparently buried all evidence for the structure of the tramway.</p>			
Condition:		Significance: Moderate	Conservation Approach:
<p>Poor. The tramway is waterlogged and part waterlogged. The stone abutments are damp and there is extensive vegetative growth.</p>			
			<p>Survey and investigation is recommended prior to any decisions in respect of better revealing the potential for this element of the tramway.</p>

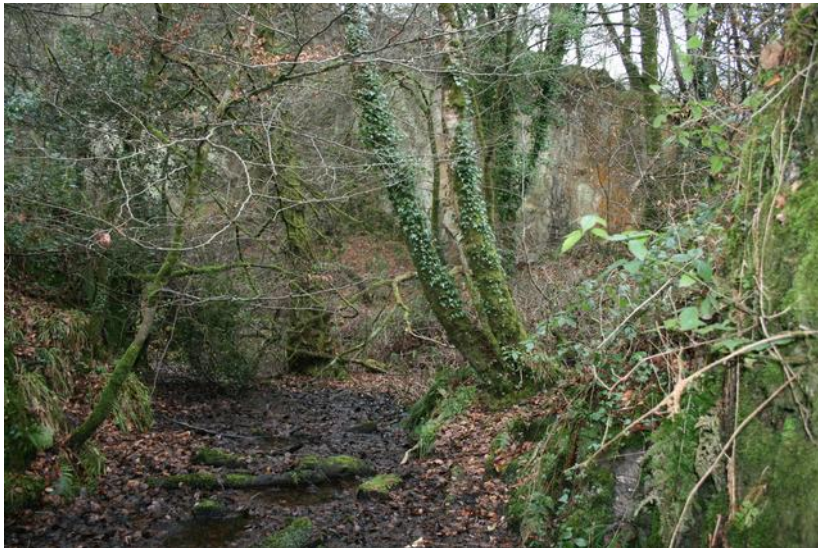
CAU Ref: Q2				
<p>Description:</p> <p>Rock Mills Quarry face from approach by tram.</p>				
<p>Condition:</p> <p>Not accessible</p>		<p>Significance: Moderate</p> <p>Part of a number of smaller stone quarries including Orchard Quarry located on the west side of the valley.</p> <p>The quarry has the potential for ecological and geological value.</p>

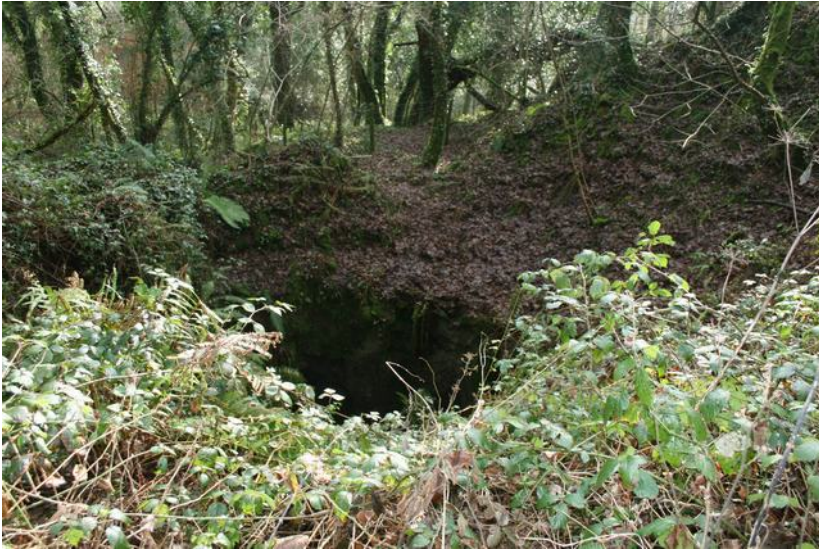
CAU Ref: M4/1			
<p>Description:</p> <p>Mine shaft part of Prideaux Wood Mine located in Carmears Wood above Pons Mill.</p>			<p>Conservation Approach:</p> <p>Management approach to be determined following survey. Decisions to consider issues of heritage value as well as those of public safety, ecology and geology.</p>
<p>Condition:</p> <p>Overgrown</p>	<p>Significance: High</p> <p>The mine has values of a historical, ecological and geological nature that all relate to the value of the WHS.</p>

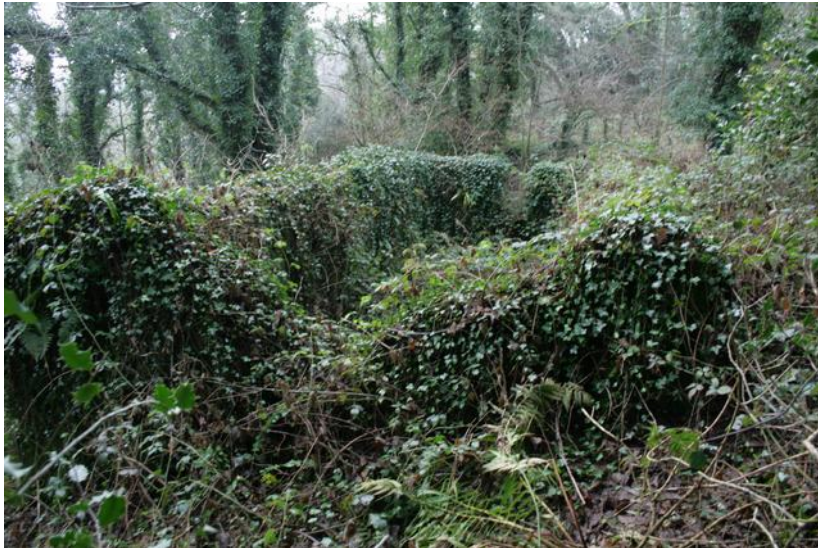
CAU Ref: M4/3	Possible boiler house at Prideaux Wood mine		
Description: Heavily overgrown remains of a building interpreted by CAU as a boiler house			Conservation Approach: The ruinous remains are vulnerable to loss and degradation arising from extensive vegetation cover. The philosophy of the CMP is that the valley should be displayed as a former mining landscape in a now naturalised setting.
Condition: Very overgrown	Significance: High		Within this context the structural integrity of the building and its heritage values need to be considered and retained.

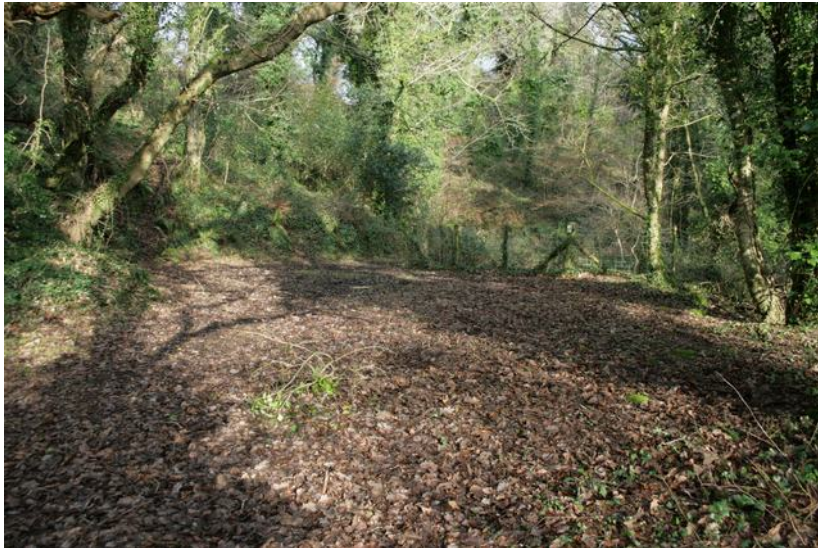
CAU Ref: M4/4	Possible capstan site		
<p>Description:</p> <p>An extensive cleared circular area adjacent to the pit could be evidence for the capstan for winding the shaft.</p>			<p>Conservation Approach:</p> <p>Manage to retain significance as part of a co-ordinated strategy of conservation in accordance with the philosophies and recommendations of the CMP in respect of visitor management, information and access.</p>
<p>Condition:</p>		<p>Significance: High</p> <p>Evidence of mine workings are significant in the context of the WHS</p>

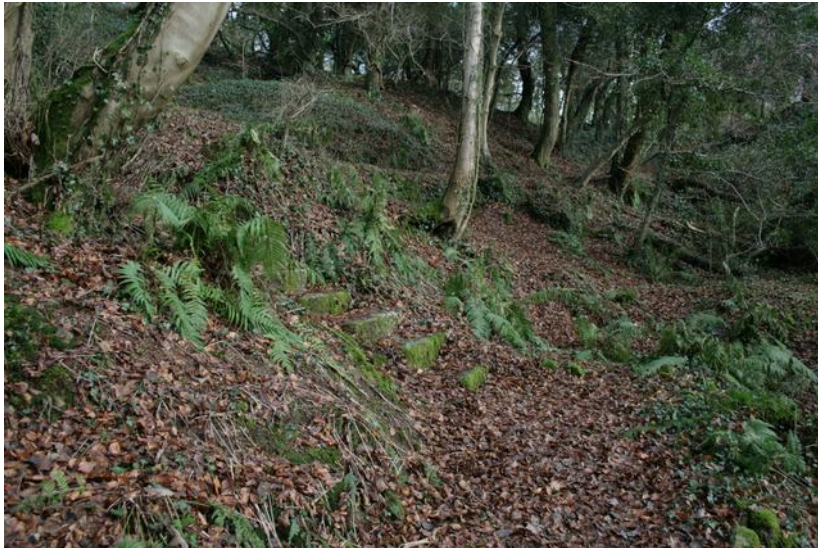
CAU Ref: M4/6			
Description: Evidence for mine waste dumping			Conservation Approach: Manage in accordance with the conservation philosophy to be adopted as part of the CMP
Condition: overgrown	Significance: Moderate

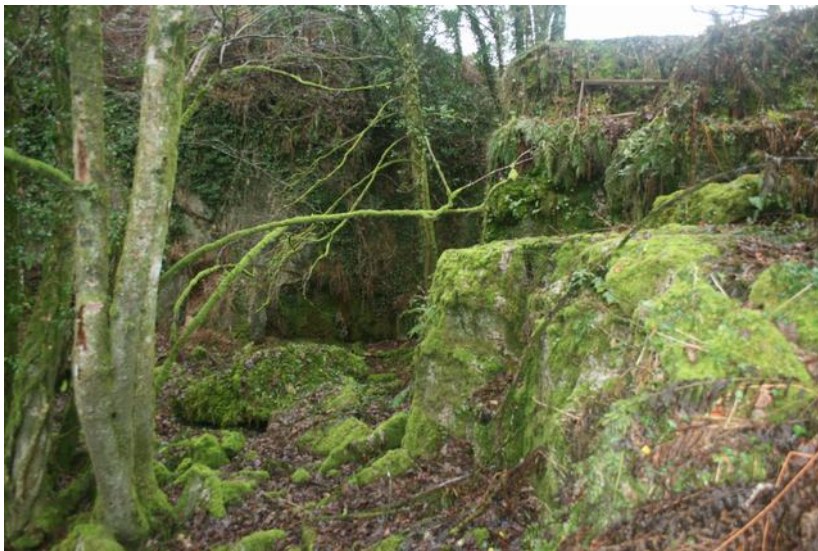
CAU Ref: Q3	Cam Bridges quarry		
Description:			Conservation Approach:
Overgrown quarry within Cam Bridges area that extends either side of the Carmears Leat. This is a shallow granite stone quarry with a number of worked edges.			
Condition:		Significance: Moderate to High	The asset is to be managed to maintain ecological, geological and historical values whilst at the same time ensuring public safety.
Overgrown and difficult of access		Evidence of quarrying within the valley has potential for historic, ecological and geological values
