Luxulyan Valley

Conservation Management Plan - Gazetteer

Cornwall Heritage
Trust

July 2011 - Rev.03

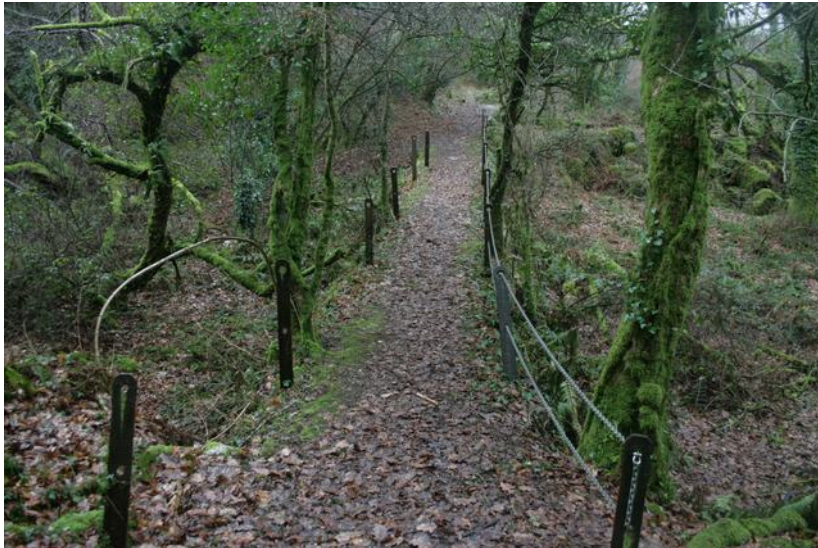
CAU Ref: Q3/4	Fenced track way		
Description:			Conservation Approach: Monitor condition.
Embanked track way or possible tram way with iron posts and railings. The track cuts across the mouth of the Cams Bridge quarry and seems therefore not associated with it. The fence posts would suggest a later 19 th century or early 20 th century date.			
Condition:		Significance: Moderate	
Good		The feature retains potential historical and evidential values. It has an aesthetic value as it passes in front of areas of granite working. .

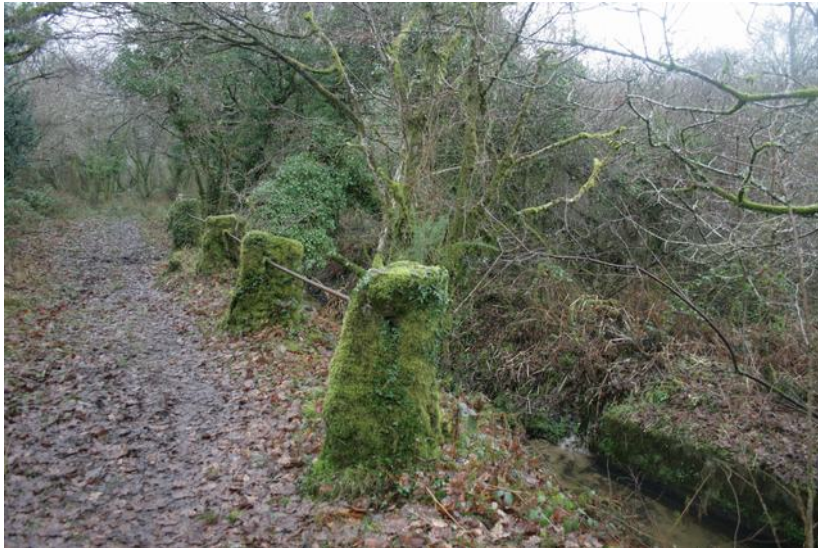
CAU Ref: Q3/4	Stone fence posts on track way		
Description:			<p>Conservation Approach:</p> <p>Monitor condition and ensure integrity of posts.</p>
<p>The track way that cuts across the quarry continues northwards to wards the sluice head and river crossings. North of the quarry the track way is defined alongside a series of stone posts of irregular shape each with a single drilled aperture to take iron railing. Some of the iron railing is preserved but its date can not be proven.</p>			
Condition:	Significance: Moderate		
Overgrown. The surface of the track way is not revealed	Potential for evidential and historical value, as it crosses the area of Cam Bridges Quarry the track way has aesthetic value.

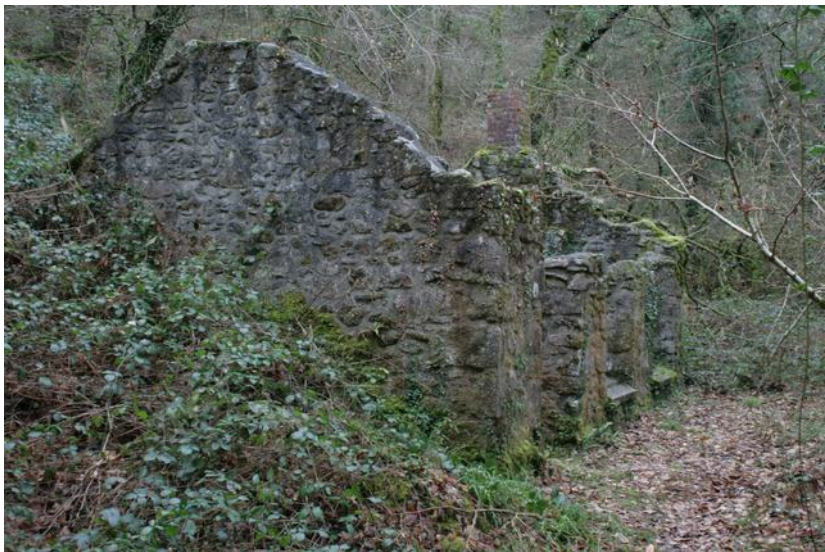
CAU Ref: M9/6				
<p>Description:</p> <p>Single storey stone built structure with gable ends, fire setting and wind ow and door openings.</p>				
Condition:		Significance: High		Conservation Approach:
Good		Evidence of mining a ctivity and associated structures are a key component of the si gnificance of th e WHS		Monitor condition

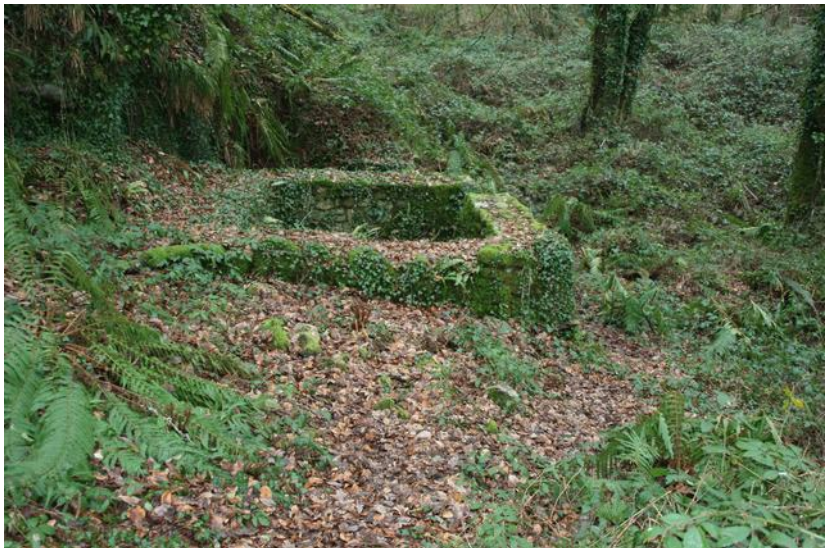
CAU Ref: M9/7			
<p>Description:</p> <p>Small square stone lined pit.</p>			
<p>Condition:</p> <p>Overgrown</p>			<p>Conservation Approach:</p> <p>Monitor condition</p>
<p>Significance: Moderate</p> <p>Evidence of mining activity and associated structures are a key component of the significance of the WHS</p>

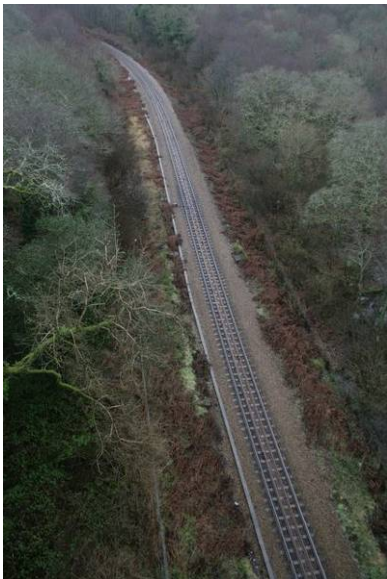
URS Ref: 74		Asset: Cornwall Mineral Railway

CAU Ref:			
Description: View of the CMR as it passes beneath the Treffry Viaduct. At this point the CMR follows the line of the river on the valley floor.			Conservation Approach:
Condition:	Significance: Moderate to Low The line of the CMR represents a departure from Treffry' s tramlines which were not suitable for locomotive traction and is an important part of the valley's infrastructure.

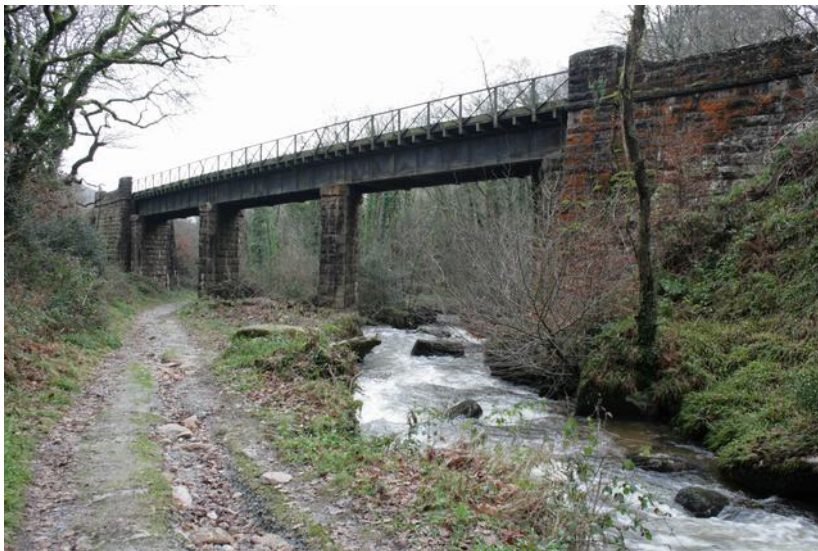
CAU Ref:	Viaduct over River par at Rock Mill		
Description:			Conservation Approach:
<p>Iron span carried on slender stone piers with stone abutments</p> <p>This specific location is one of aesthetic value that contributes to the heritage values of both the CMR and the Rock Mill Tramway which passes beneath the viaduct.</p>			
Condition:		Significance: Moderate

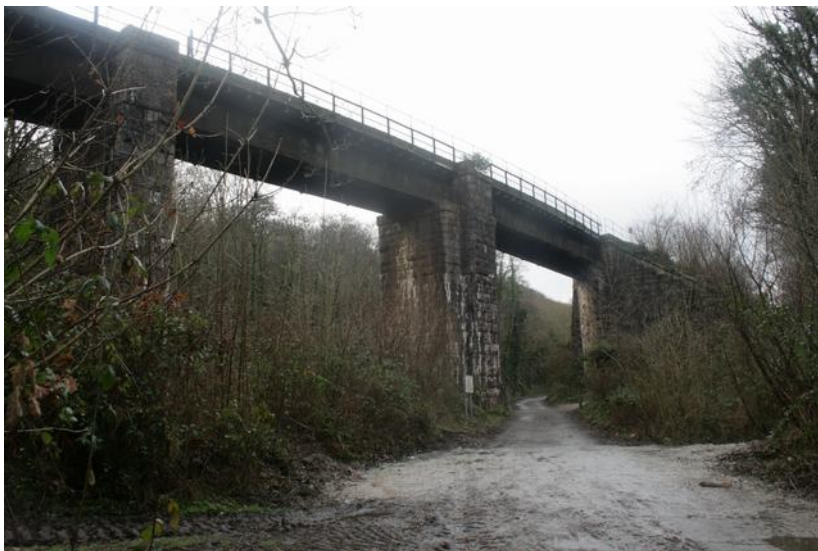
CAU Ref:			
<p>Description:</p> <p>Iron span bridge on slender stone piers that carries the CMR above Ponds Mill providing a bridge to the Rock Mill Tramway.</p> <p>The viaduct has aesthetic value that contributes to the group values and overall significance of the monuments at Ponds Mill.</p>			
Condition:		Significance: Moderate
